# Access Compliance Report

## Public Rights-of-Way

### (Curb Ramps)

Intersection ID: 51504	Main Street: DUNSLOW_CT	Cross Street: EASTFIELD_PARK_DR	Location: E
ADA ID: 6B3B45893C32	Ramp Type: PerpDiag	Initial Pass/Fail: Fail	Overall Compliance: No
Severity Score: 12.5			
Codes/Mitigation Info/Possible Solution		Field Measurements/Component Compliance

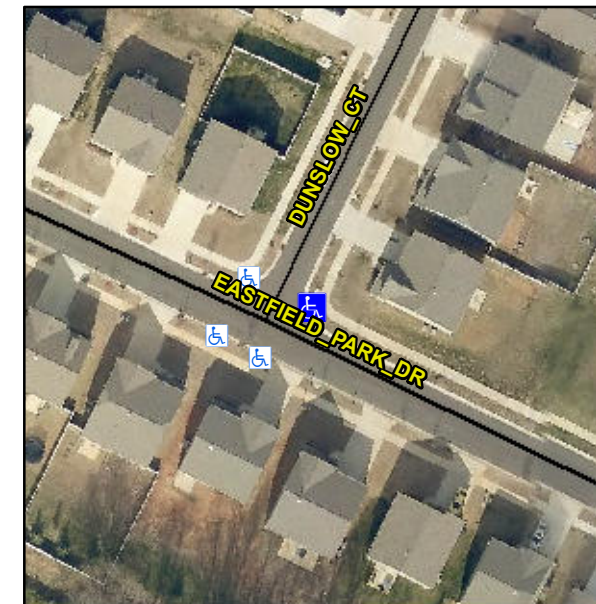
**Not Found, R304.5.3**

Compliance	Description	Data	Compliance	Description	Data
N/A	Ramp Length (in)	64.0	Yes	Ramp Slope (%)	5.1
Yes	Ramp Width (in)	48.0	No	Ramp XSlope (%)	5.6
N/A	Flare Type LT	N/A	N/A	Flare Type RT	N/A
N/A	Flare Slope LT (%)	N/A	N/A	Flare Slope RT (%)	N/A
N/A	Flare Traversable LT?	N/A	N/A	Flare Traversable RT?	N/A
N/A	Landing Length (in)	N/A	N/A	DWS Provided?	N/A
N/A	Landing Width (in)	N/A	N/A	DWS Contrast?	N/A
N/A	Landing Slope (%)	N/A	N/A	DWS Length (in)	N/A
N/A	Landing X Slope (%)	N/A	N/A	DWS Full Width?	N/A
N/A	Landing Curb? (Y/N)	N/A	N/A	DWS Offset (in)	N/A
N/A	Shared Landing?	N/A			
N/A	Gutter Ponding?	N/A	N/A	Gutter Slope (%)	N/A
N/A	Gutter Lip Ht (in)	N/A	N/A	Gutter X Slope (%)	N/A
N/A	Painted X Walk1?	No	N/A	Painted X Walk2?	No
	X Walk 1 Direction	To NW		X Walk 2 Direction	To SW
N/A	X Walk 1 Width (in)	N/A	N/A	X Walk 2 Width (in)	N/A
	X Walk 1 Slope (%)	1.1		X Walk 2 Slope (%)	4.9
	X Walk 1 X Slope (%)	5.7		X Walk 2 X Slope (%)	2.4

N/A	Ramp inside XWalk1?	N/A	N/A	Ramp inside XWalk2?	N/A
	Road Slope (%)	3.5	N/A	Clear Space?	N/A
	Road X Slope (%)	4.1	N/A	Clear Space to XWalk (in)	N/A
N/A	Any Obstructions?	N/A	N/A	Storm Grate/Utility Hazard?	N/A
	Obstruction Type			Storm Grate/Utility Type	
		N/A			N/A
			Yes	Surface Condition? (G/P)	Good

**Remove & Replace Curb Ramp With Two New Directional Ramps or Equivalent.**
