Access Compliance Report

Public Rights-of-Way

(Curb Ramps)

Intersection ID: 30374	Main Street: EASTWAY_CROSSING_DR	Cross Street: EASTWAY_DR	Location: NE
ADA ID: 6B43C62D128A	Ramp Type: Perp	Initial Pass/Fail: Fail	Overall Compliance: No
Codes/Mitigation Info/Possible Solution		Field Measurements/Component Compliance	
Severity Score: 33.75

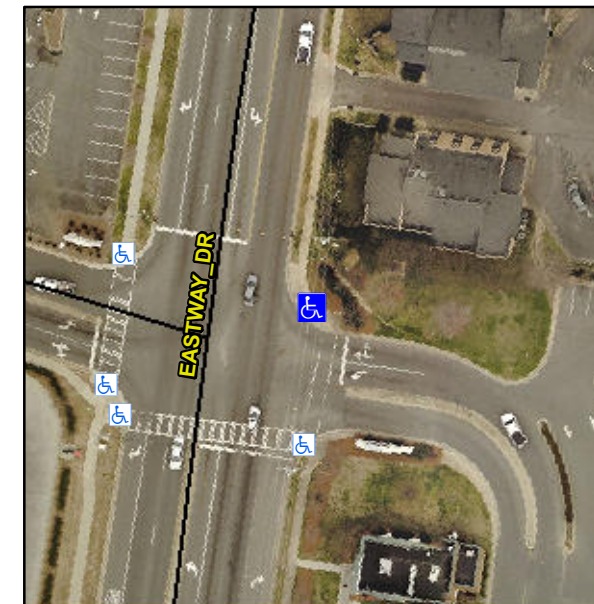
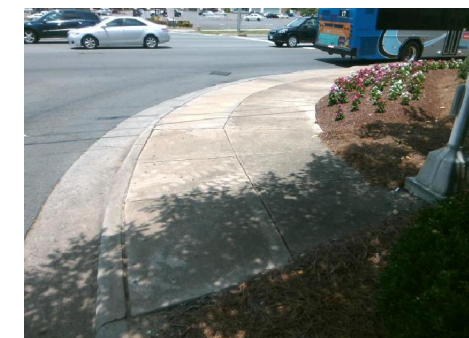
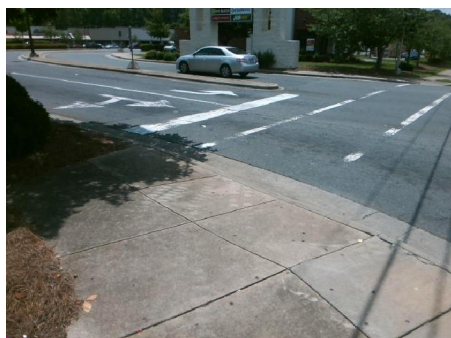
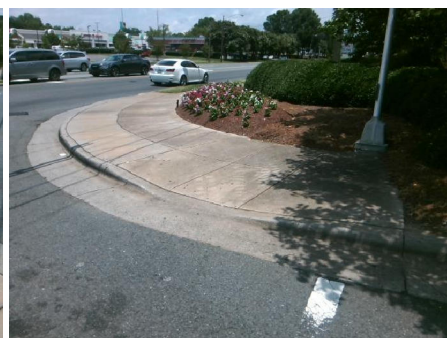
Not Found, R304.5.1, R304.2.2, R304.5.3

Compliance	Description	Data	Compliance	Description	Data
N/A	Ramp Length (in)	99.0	No	Ramp Slope (%)	10.2
No	Ramp Width (in)	36.5	No	Ramp XSlope (%)	5.1
N/A	Flare Type LT	N/A	N/A	Flare Type RT	N/A
N/A	Flare Slope LT (%)	N/A	N/A	Flare Slope RT (%)	N/A
N/A	Flare Traversable LT?	N/A	N/A	Flare Traversable RT?	N/A
N/A	Landing Length (in)	N/A	N/A	DWS Provided?	N/A
N/A	Landing Width (in)	N/A	N/A	DWS Contrast?	N/A
N/A	Landing Slope (%)	N/A	N/A	DWS Length (in)	N/A
N/A	Landing X Slope (%)	N/A	N/A	DWS Full Width?	N/A
N/A	Landing Curb? (Y/N)	N/A	N/A	DWS Offset (in)	N/A
N/A	Shared Landing?	N/A			
N/A	Gutter Ponding?	N/A	N/A	Gutter Slope (%)	N/A
N/A	Gutter Lip Ht (in)	N/A	N/A	Gutter X Slope (%)	N/A
N/A	Painted X Walk1?	Yes	N/A	Painted X Walk2?	N/A
	X Walk 1 Direction	To S		X Walk 2 Direction	N/A
N/A	X Walk 1 Width (in)	83.0	N/A	X Walk 2 Width (in)	N/A
	X Walk 1 Slope (%)	0.5		X Walk 2 Slope (%)	N/A
	X Walk 1 X Slope (%)	2.4		X Walk 2 X Slope (%)	N/A

N/A	Ramp inside XWalk1?	Yes	N/A	Ramp inside XWalk2?	N/A
	Road Slope (%)	N/A	N/A	Clear Space?	N/A
	Road X Slope (%)	N/A	N/A	Clear Space to XWalk (in)	N/A
N/A	Any Obstructions?	N/A	N/A	Storm Grate/Utility Hazard?	N/A
	Obstruction Type			Storm Grate/Utility Type	
		N/A			N/A
			Yes	Surface Condition? (G/P)	Good

Possible Solutions:

Remove & Replace Entire Ramp.
