Access Compliance Report

Public Rights-of-Way

(Curb Ramps)

Intersection ID: 50633	Main Street: BLUE_BLOSSOM_RD	Cross Street: CORAL_ROSE_RD	Location:	S
ADA ID: 6B45CB730A88	Ramp Type: BlendTrans1	Initial Pass/Fail: Fail	Overall Compliance: No	Severity Score: 1.25
Codes/Mitigation Info/Possible Solution		Field Measurements/Component Compliance

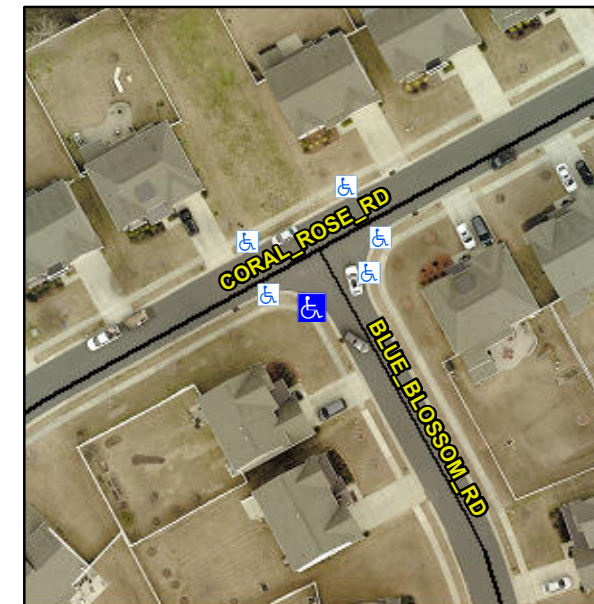
Not Found, R304.5.3

Compliance	Description	Data	Compliance	Description	Data
N/A	Ramp Length (in)	48.0	Yes	BlendTrans Slope (%)	4.2
Yes	Ramp Width (in)	48.0	No	BlendTrans XSlope (%)	4.2
N/A	Flare Type LT	N/A	N/A	Flare Type RT	N/A
N/A	Flare Slope LT (%)	N/A	N/A	Flare Slope RT (%)	N/A
N/A	Flare Traversable LT?	N/A	N/A	Flare Traversable RT?	N/A
N/A	Landing Length (in)	N/A	N/A	DWS Provided?	N/A
N/A	Landing Width (in)	N/A	N/A	DWS Contrast?	N/A
N/A	Landing Slope (%)	N/A	N/A	DWS Length (in)	N/A
N/A	Landing X Slope (%)	N/A	N/A	DWS Full Width?	N/A
N/A	Landing Curb? (Y/N)	N/A	N/A	DWS Offset (in)	N/A
N/A	Shared Landing?	N/A			
N/A	Gutter Ponding?	N/A	N/A	Gutter Slope (%)	N/A
N/A	Gutter Lip Ht (in)	N/A	N/A	Gutter X Slope (%)	N/A
N/A	Painted X Walk1?	No	N/A	Painted X Walk2?	N/A
	X Walk 1 Direction	To NE		X Walk 2 Direction	N/A
	X Walk 1 Width (in)	N/A		X Walk 2 Width (in)	N/A
	X Walk 1 Slope (%)	1.3		X Walk 2 Slope (%)	N/A
	X Walk 1 X Slope (%)	4.6		X Walk 2 X Slope (%)	N/A

N/A	Ramp inside XWalk1?	N/A	N/A	Ramp inside XWalk2?	N/A
	Road Slope (%)	4.6		Clear Space?	N/A
	Road X Slope (%)	1.3	N/A	Clear Space to XWalk (in)	N/A
N/A	Any Obstructions?	N/A	N/A	Storm Grate/Utility Hazard?	N/A
	Obstruction Type			Storm Grate/Utility Type	
		N/A			N/A
			Yes	Surface Condition? (G/P)	Good
			No	Curb Slope (%)	15.7

Remove & Replace Curb Ramp With Two New Directional Ramps or Equivalent.
