Access Compliance Report

Public Rights-of-Way

(Curb Ramps)

Intersection ID: 23148	Main Street: ALEXANDER_RD	Cross Street: HARRISON_RD	Location: NE
ADA ID: 6B536CA43D35	Ramp Type: Perp	Initial Pass/Fail: Fail	Overall Compliance: No
Severity Score: 26.25			
Codes/Mitigation Info/Possible Solution		Field Measurements/Component Compliance

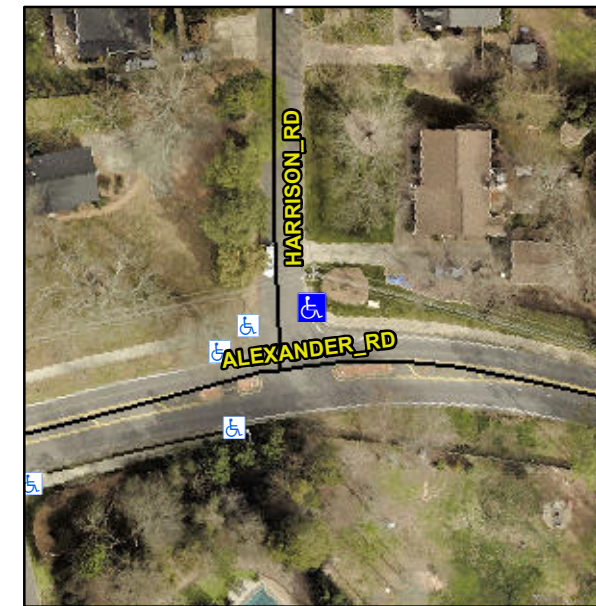
Not Found, R304.2.2, R304.5.3

Compliance	Description	Data	Compliance	Description	Data
N/A	Ramp Length (in)	48.0	No	Ramp Slope (%)	14.4
Yes	Ramp Width (in)	48.0	No	Ramp XSlope (%)	3.6
N/A	Flare Type LT	N/A	N/A	Flare Type RT	N/A
N/A	Flare Slope LT (%)	N/A	N/A	Flare Slope RT (%)	N/A
N/A	Flare Traversable LT?	N/A	N/A	Flare Traversable RT?	N/A
N/A	Landing Length (in)	N/A	N/A	DWS Provided?	N/A
N/A	Landing Width (in)	N/A	N/A	DWS Contrast?	N/A
N/A	Landing Slope (%)	N/A	N/A	DWS Length (in)	N/A
N/A	Landing X Slope (%)	N/A	N/A	DWS Full Width?	N/A
N/A	Landing Curb? (Y/N)	N/A	N/A	DWS Offset (in)	N/A
N/A	Shared Landing?	N/A			
N/A	Gutter Ponding?	N/A	N/A	Gutter Slope (%)	N/A
N/A	Gutter Lip Ht (in)	3.0	N/A	Gutter X Slope (%)	N/A
N/A	Painted X Walk1?	No	N/A	Painted X Walk2?	N/A
	X Walk 1 Direction	To W		X Walk 2 Direction	N/A
N/A	X Walk 1 Width (in)	N/A	N/A	X Walk 2 Width (in)	N/A
	X Walk 1 Slope (%)	3.3		X Walk 2 Slope (%)	N/A
	X Walk 1 X Slope (%)	2.6		X Walk 2 X Slope (%)	N/A

Remove & Replace Entire Ramp.

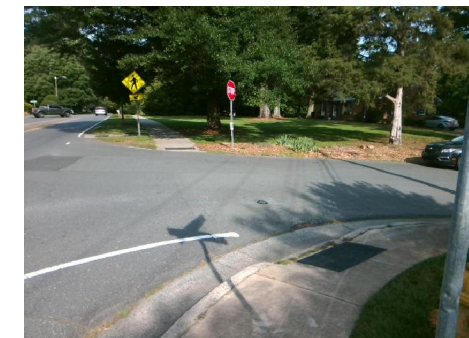
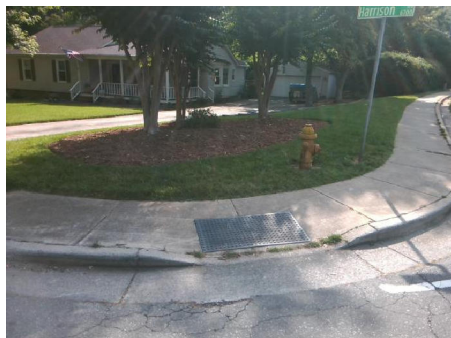
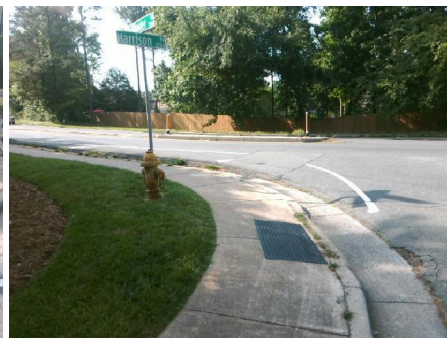
N/A	Ramp inside XWalk1?	N/A	N/A	Ramp inside XWalk2?	N/A
	Road Slope (%)	N/A	N/A	Clear Space?	N/A
	Road X Slope (%)	N/A	N/A	Clear Space to XWalk (in)	N/A
N/A	Any Obstructions?	N/A	N/A	Storm Grate/Utility Hazard?	N/A
	Obstruction Type			Storm Grate/Utility Type	
		N/A			N/A
		Yes		Surface Condition? (G/P)	Good
