# Access Compliance Report

## Public Rights-of-Way

### (Curb Ramps)

| Intersection ID: 6039 | Main Street: DELLINGER_DR | Cross Street: MILHAVEN_LN | Location: NW |

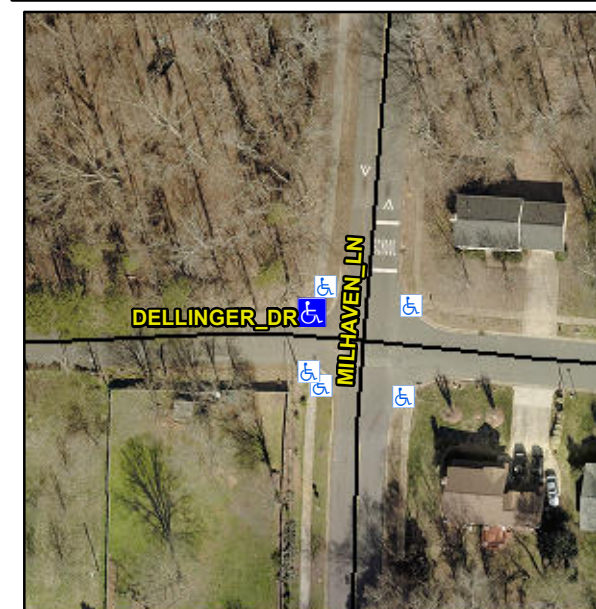
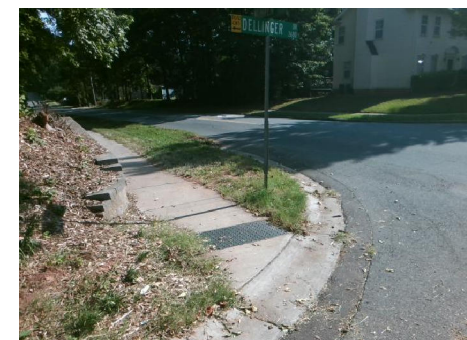
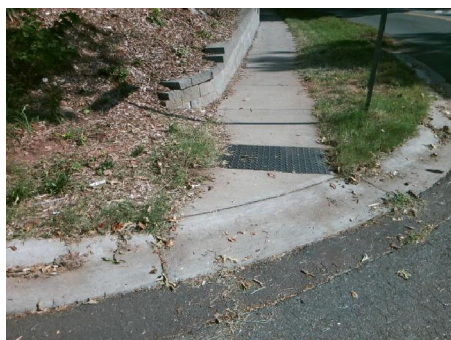
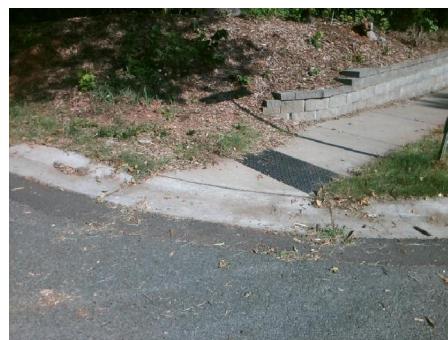
| ADA ID: 6B58239B45B1 | Ramp Type: BlendTrans1 | Initial Pass/Fail: Fail | Overall Compliance: No |

**Not Found, R304.5.3**

| Compliance | Description | Data | Compliance | Description | Data |
|---|---|---|---|---|---|
| Yes | Ramp Width (in) | 59.0 | No | BlendTrans XSlope (%) | 5.4 |
| | | | No | Curb Slope (%) | 7.6 |

**Remove & Replace Curb Ramp With Two New Directional Ramps or Equivalent.**
