# Access Compliance Report

## Public Rights-of-Way

### (Curb Ramps)

| Intersection ID: 10022971 | Main Street: CEDAR_WALK_LN | Cross Street: N/A | Location: NE |

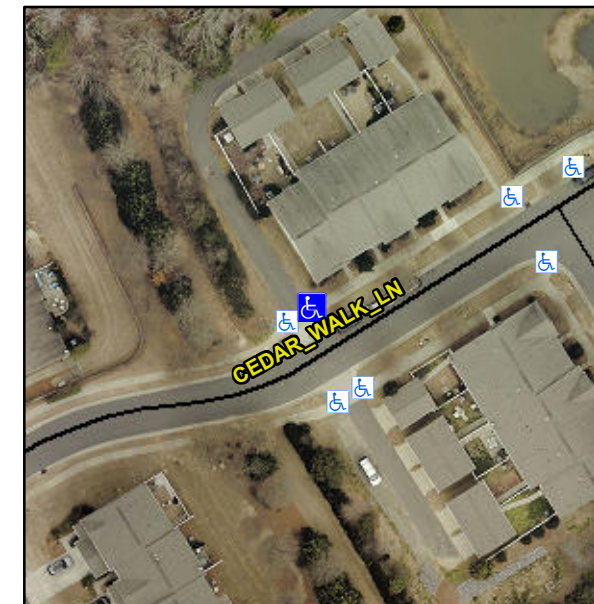
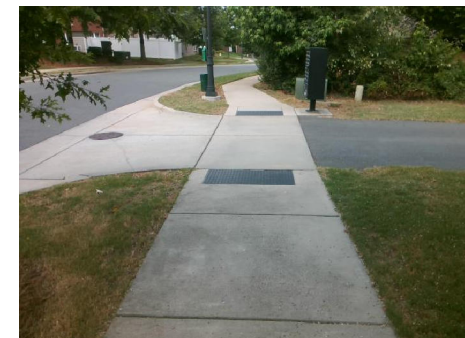
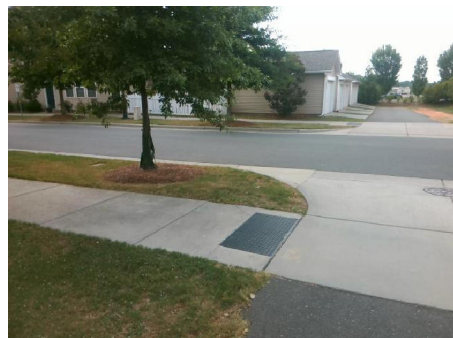
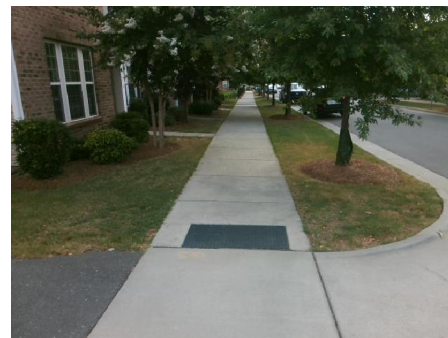
| ADA ID: 6B58A2CED729 | Ramp Type: BlendTrans1 | Initial Pass/Fail: Pass | Overall Compliance: No |

**NO CURB**

**R304.5.3, R304.2.1**

| Compliance | Description | Data | Compliance | Description | Data |
|---|---|---|---|---|---|
| Yes | Ramp Width (in) | 72.0 | No | BlendTrans XSlope (%) | 2.3 |
| No | Landing Length (in) | 34.0 | Yes | DWS Provided? | Yes |

**Remove & Replace Curb Ramp With Two New Directional Ramps or Equivalent.**

Total Cost: \$ 3200.00
