# Access Compliance Report

## Public Rights-of-Way

### (Curb Ramps)

| Intersection ID: 15916 | Main Street: BRANDON_RD | Cross Street: PEMBROKE_AV | Location: SW |

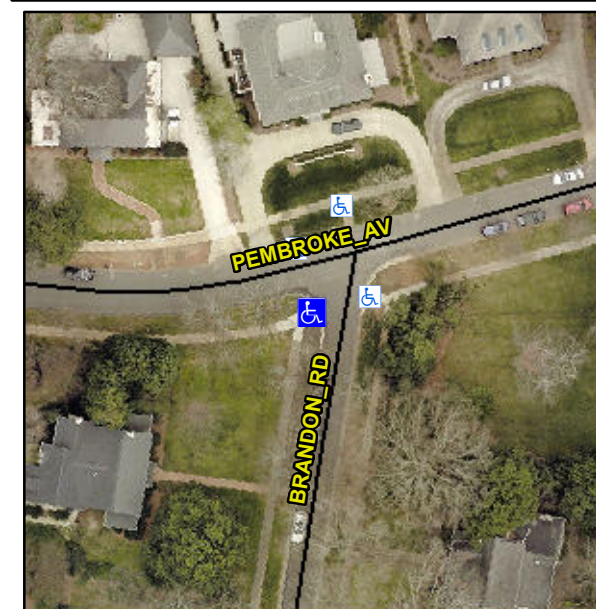
| ADA ID: 6B58E8C03E2C | Ramp Type: PerpDiag | Initial Pass/Fail: Pass | Overall Compliance: No |
| Severity Score: 5 | | | |

| Compliance | Description | Data | Compliance | Description | Data |
|---|---|---|---|---|---|
| No | Flare Type | Curbed_WithWalkSurface | No | Flare Type RT | N/A |
| No | Flare Slope LT (%) | N/A | N/A | Flare Slope RT (%) | N/A |
| Yes | Gutter Lip Ht (in) | 0.0 | No | Gutter X Slope (%) | 5.5 |

**Remove & Replace Curb Ramp With Two New Directional Ramps or Equivalent. Remove & Replace Gutter.**

**R304.2.3, R304.5.3**

Total Cost: \$ 3950.00
