Access Compliance Report

Public Rights-of-Way

(Curb Ramps)

Intersection ID: 29216	Main Street: BAUCOM_RD	Cross Street: BRATHAY_CT	Location: NW
ADA ID: 6B628A476F83	Ramp Type: Perp	Initial Pass/Fail: Fail	Overall Compliance: No
			Severity Score: 21.25

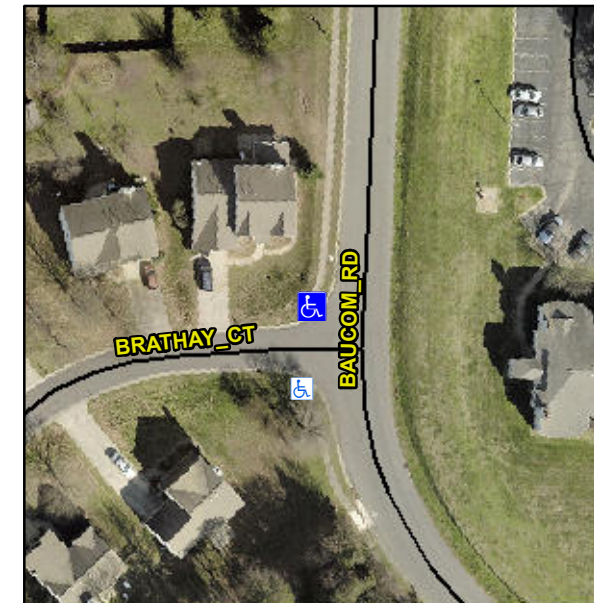
Not Found, R304.5.1, R304.5.3

Compliance	Description	Data	Compliance	Description	Data
N/A	Ramp Length (in)	48.0	Yes	Ramp Slope (%)	7.0
No	Ramp Width (in)	45.0	No	Ramp XSlope (%)	5.5
N/A	Flare Type LT	N/A	N/A	Flare Type RT	N/A
N/A	Flare Slope LT (%)	N/A	N/A	Flare Slope RT (%)	N/A
N/A	Flare Traversable LT?	N/A	N/A	Flare Traversable RT?	N/A
N/A	Landing Length (in)	N/A	N/A	DWS Provided?	N/A
N/A	Landing Width (in)	N/A	N/A	DWS Contrast?	N/A
N/A	Landing Slope (%)	N/A	N/A	DWS Length (in)	N/A
N/A	Landing X Slope (%)	N/A	N/A	DWS Full Width?	N/A
N/A	Landing Curb? (Y/N)	N/A	N/A	DWS Offset (in)	N/A
N/A	Shared Landing?	N/A			
N/A	Gutter Ponding?	N/A	N/A	Gutter Slope (%)	N/A
N/A	Gutter Lip Ht (in)	N/A	N/A	Gutter X Slope (%)	N/A
N/A	Painted X Walk1?	No	N/A	Painted X Walk2?	N/A
	X Walk 1 Direction	To S		X Walk 2 Direction	N/A
N/A	X Walk 1 Width (in)	N/A	N/A	X Walk 2 Width (in)	N/A
	X Walk 1 Slope (%)	0.7		X Walk 2 Slope (%)	N/A
	X Walk 1 X Slope (%)	4.0		X Walk 2 X Slope (%)	N/A

N/A	Ramp inside XWalk1?	N/A	N/A	Ramp inside XWalk2?	N/A
	Road Slope (%)	N/A	N/A	Clear Space?	N/A
	Road X Slope (%)	N/A	N/A	Clear Space to XWalk (in)	N/A
N/A	Any Obstructions?	N/A	N/A	Storm Grate/Utility Hazard?	N/A
	Obstruction Type			Storm Grate/Utility Type	
		N/A			N/A
			Yes	Surface Condition? (G/P)	Good

Remove & Replace Entire Ramp.
