Access Compliance Report

Public Rights-of-Way

(Curb Ramps)

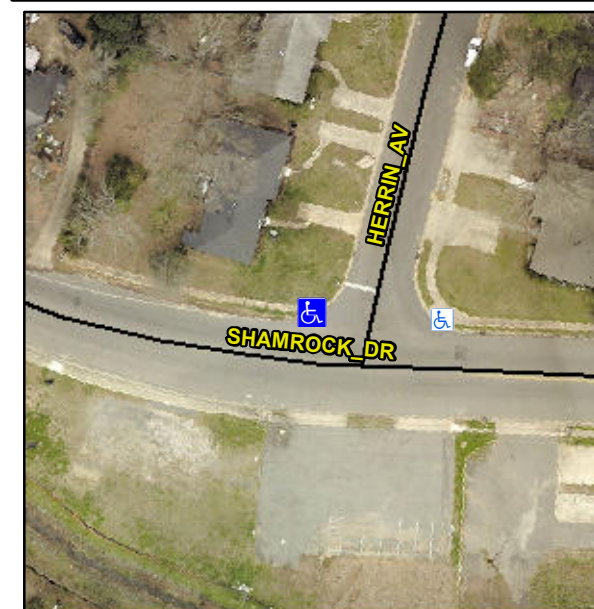
Intersection ID: 11338	Main Street: HERRIN_AV	Cross Street: SHAMROCK_DR	Location: NW
ADA ID: 6B6A4C7B383E	Ramp Type: Perp	Initial Pass/Fail: Fail	Overall Compliance: No
Severity Score: 21.25			
Codes/Mitigation Info/Possible Solution		Field Measurements/Component Compliance

Not Found, R304.5.1, R304.2.2

Compliance	Description	Data	Compliance	Description	Data
N/A	Ramp Length (in)	29.0	No	Ramp Slope (%)	10.9
No	Ramp Width (in)	40.0	Yes	Ramp XSlope (%)	1.7
N/A	Flare Type LT	N/A	N/A	Flare Type RT	N/A
N/A	Flare Slope LT (%)	N/A	N/A	Flare Slope RT (%)	N/A
N/A	Flare Traversable LT?	N/A	N/A	Flare Traversable RT?	N/A
N/A	Landing Length (in)	N/A	N/A	DWS Provided?	N/A
N/A	Landing Width (in)	N/A	N/A	DWS Contrast?	N/A
N/A	Landing Slope (%)	N/A	N/A	DWS Length (in)	N/A
N/A	Landing X Slope (%)	N/A	N/A	DWS Full Width?	N/A
N/A	Landing Curb? (Y/N)	N/A	N/A	DWS Offset (in)	N/A
N/A	Shared Landing?	N/A			
N/A	Gutter Ponding?	N/A	N/A	Gutter Slope (%)	N/A
N/A	Gutter Lip Ht (in)	N/A	N/A	Gutter X Slope (%)	N/A
N/A	Painted X Walk1?	No	N/A	Painted X Walk2?	N/A
	X Walk 1 Direction	To SE		X Walk 2 Direction	N/A
N/A	X Walk 1 Width (in)	N/A	N/A	X Walk 2 Width (in)	N/A
	X Walk 1 Slope (%)	0.2		X Walk 2 Slope (%)	N/A
	X Walk 1 X Slope (%)	5.3		X Walk 2 X Slope (%)	N/A

N/A	Ramp inside XWalk1?	N/A	N/A	Ramp inside XWalk2?	N/A
	Road Slope (%)	N/A	N/A	Clear Space?	N/A
	Road X Slope (%)	N/A	N/A	Clear Space to XWalk (in)	N/A
N/A	Any Obstructions?	N/A	N/A	Storm Grate/Utility Hazard?	N/A
	Obstruction Type			Storm Grate/Utility Type	
		N/A			N/A
		Yes		Surface Condition? (G/P)	Good

Remove & Replace Entire Ramp.
