Access Compliance Report

Public Rights-of-Way

(Curb Ramps)

Intersection ID: 10017771	Main Street: OLD_STATESVILLE_RD	Cross Street: N/A	Location: W
ADA ID: 6B6CFDFE527E	Ramp Type: Perp	Initial Pass/Fail: Fail	Overall Compliance: No
Severity Score: 33.75			
Codes/Mitigation Info/Possible Solution		Field Measurements/Component Compliance

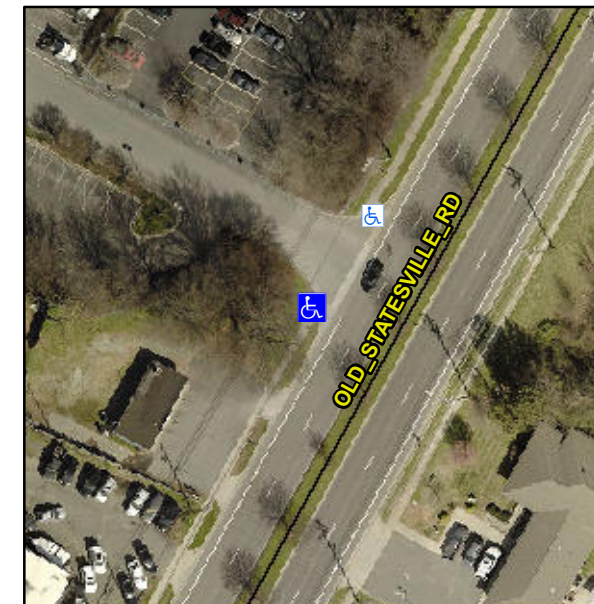
R304.5.1, R304.2.2

Compliance	Description	Data	Compliance	Description	Data
N/A	Ramp Length (in)	44.0	No	Ramp Slope (%)	15.3
No	Ramp Width (in)	37.5	Yes	Ramp XSlope (%)	0.8
N/A	Flare Type LT	N/A	N/A	Flare Type RT	N/A
N/A	Flare Slope LT (%)	N/A	N/A	Flare Slope RT (%)	N/A
N/A	Flare Traversable LT?	N/A	N/A	Flare Traversable RT?	N/A
N/A	Landing Length (in)	N/A	N/A	DWS Provided?	N/A
N/A	Landing Width (in)	N/A	N/A	DWS Contrast?	N/A
N/A	Landing Slope (%)	N/A	N/A	DWS Length (in)	N/A
N/A	Landing X Slope (%)	N/A	N/A	DWS Full Width?	N/A
N/A	Landing Curb? (Y/N)	N/A	N/A	DWS Offset (in)	N/A
N/A	Shared Landing?	N/A			
N/A	Gutter Ponding?	N/A	N/A	Gutter Slope (%)	N/A
N/A	Gutter Lip Ht (in)	N/A	N/A	Gutter X Slope (%)	N/A
N/A	Painted X Walk1?	No	N/A	Painted X Walk2?	N/A
	X Walk 1 Direction	To N		X Walk 2 Direction	N/A
N/A	X Walk 1 Width (in)	N/A	N/A	X Walk 2 Width (in)	N/A
	X Walk 1 Slope (%)	0.6		X Walk 2 Slope (%)	N/A
	X Walk 1 X Slope (%)	5.2		X Walk 2 X Slope (%)	N/A

N/A	Ramp inside XWalk1?	N/A	N/A	Ramp inside XWalk2?	N/A
	Road Slope (%)	N/A	N/A	Clear Space?	N/A
	Road X Slope (%)	N/A	N/A	Clear Space to XWalk (in)	N/A
N/A	Any Obstructions?	N/A	N/A	Storm Grate/Utility Hazard?	N/A
	Obstruction Type			Storm Grate/Utility Type	
		N/A			N/A
			Yes	Surface Condition? (G/P)	Good

Remove & Replace Entire Ramp.

Total Cost: \$ 1850.00
