Access Compliance Report

Public Rights-of-Way

(Curb Ramps)

Intersection ID: 47276	Main Street: CARRINGTON_FOREST_LN	Cross Street: MCKEE_RD	Location: SE
ADA ID: 6B86B04351D2	Ramp Type: Perp	Initial Pass/Fail: Fail	Overall Compliance: No
Severity Score: 8.75			
Codes/Mitigation Info/Possible Solution		Field Measurements/Component Compliance

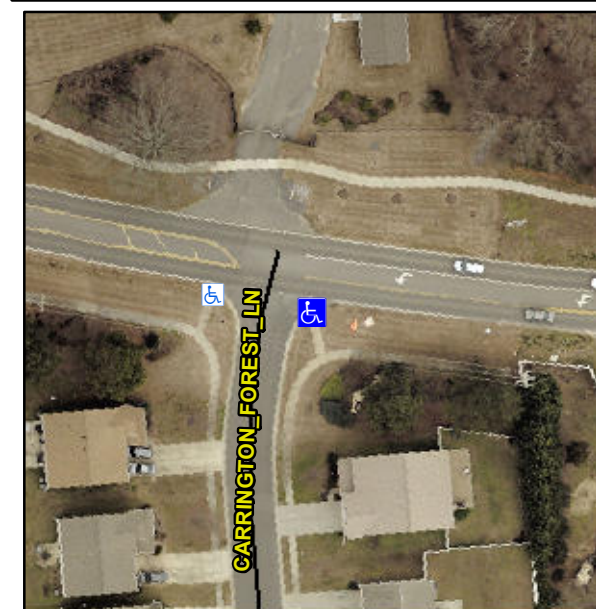
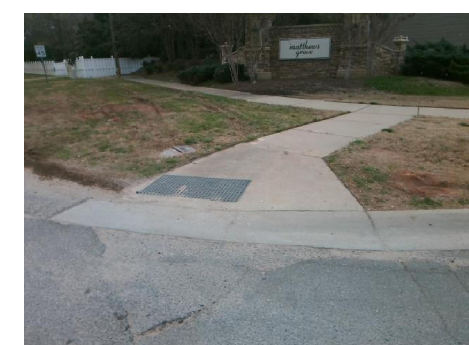
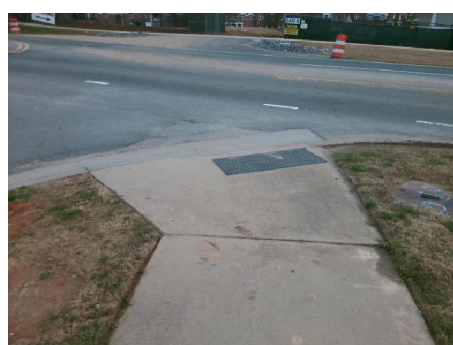
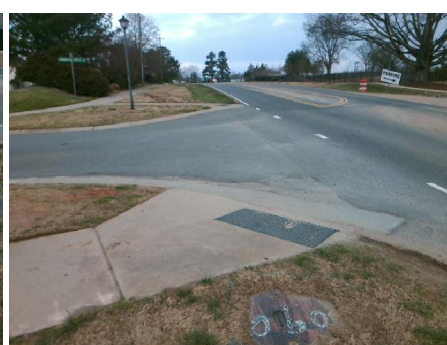
Compliance	Description	Data	Compliance	Description	Data
N/A	Ramp Length (in)	39.0	Yes	Ramp Slope (%)	5.5
No	Ramp Width (in)	46.0	Yes	Ramp XSlope (%)	0.5
N/A	Flare Type LT	N/A	N/A	Flare Type RT	N/A
N/A	Flare Slope LT (%)	N/A	N/A	Flare Slope RT (%)	N/A
N/A	Flare Traversable LT?	N/A	N/A	Flare Traversable RT?	N/A
N/A	Landing Length (in)	N/A	N/A	DWS Provided?	N/A
N/A	Landing Width (in)	N/A	N/A	DWS Contrast?	N/A
N/A	Landing Slope (%)	N/A	N/A	DWS Length (in)	N/A
N/A	Landing X Slope (%)	N/A	N/A	DWS Full Width?	N/A
N/A	Landing Curb? (Y/N)	N/A	N/A	DWS Offset (in)	N/A
N/A	Shared Landing?	N/A			
N/A	Gutter Ponding?	N/A	N/A	Gutter Slope (%)	N/A
N/A	Gutter Lip Ht (in)	N/A	N/A	Gutter X Slope (%)	N/A
N/A	Painted X Walk1?	No	N/A	Painted X Walk2?	N/A
	X Walk 1 Direction	To W		X Walk 2 Direction	N/A
N/A	X Walk 1 Width (in)	N/A	N/A	X Walk 2 Width (in)	N/A
	X Walk 1 Slope (%)	3.0		X Walk 2 Slope (%)	N/A
	X Walk 1 X Slope (%)	0.9		X Walk 2 X Slope (%)	N/A

N/A	Ramp inside XWalk1?	N/A	N/A	Ramp inside XWalk2?	N/A
	Road Slope (%)	N/A	N/A	Clear Space?	N/A
	Road X Slope (%)	N/A	N/A	Clear Space to XWalk (in)	N/A
N/A	Any Obstructions?	N/A	N/A	Storm Grate/Utility Hazard?	N/A
	Obstruction Type			Storm Grate/Utility Type	
		N/A			N/A
			Yes	Surface Condition? (G/P)	Good

Possible Solutions:

Remove & Replace Entire Ramp.

R304.5.1
