# Access Compliance Report

## Public Rights-of-Way

| Intersection ID: 15053 | Main Street: COLVILLE_RD | Cross Street: FENTON_PL | Location: SW |
| ADA ID: 6B95ECADE21A | Ramp Type: BlendTrans2 | Initial Pass/Fail: Fail | Overall Compliance: No |

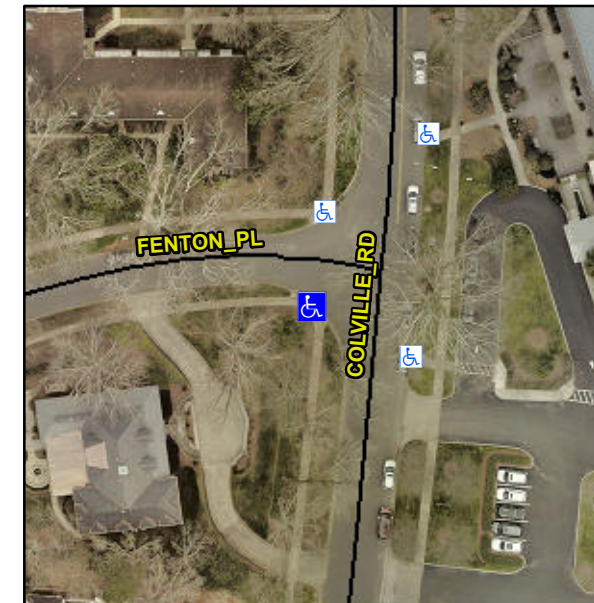
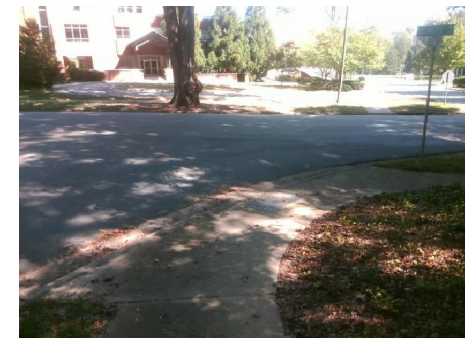
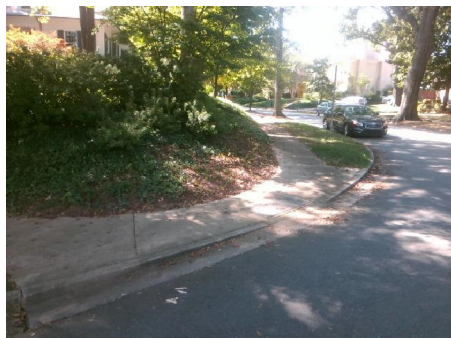
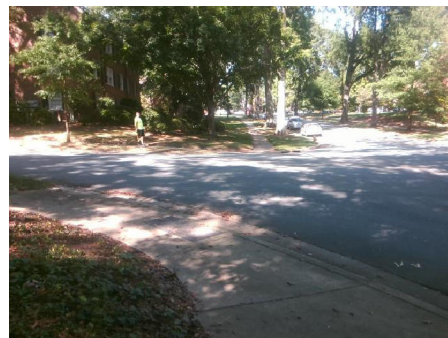
| | | Severity Score: 25 | |

**R304.5.3**

| Compliance | Description | Data | Compliance | Description | Data |
|---|---|---|---|---|---|
| Yes | Ramp Width (in) | 54.0 | No | BlendTrans XSlope (%) | 10.9 |

**Remove & Replace Curb Ramp With Two New Directional Ramps or Equivalent.**

Total Cost: \$ 3200.00
