## Access Compliance Report Public Rights-of-Way (Curb Ramps)

Intersection ID: 19730 Main Street: SOUTH\_PARK\_DR Cross Street: MORRISON\_BV Location: NE

ADA ID: 6B99C8DBC90A Ramp Type: PerpDiag Initial Pass/Fail: Fail Overall Compliance: No Severity Score: 25

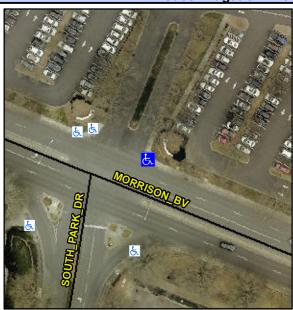
Not Found, R304.2.2

Compliance Description <u>Data</u> Compliance Description Data No N/A Ramp Length (in) 48.0 Ramp Slope (%) 12.0 Yes Ramp XSlope (%) Yes Ramp Width (in) 48.0 0.4 N/A N/A Flare Type LT N/A Flare Type RT N/A N/A Flare Slope LT (%) N/A N/A Flare Slope RT (%) N/A N/A Flare Traversable LT? N/A N/A Flare Traversable RT? N/A N/A N/A N/A DWS Provided? N/A Landing Length (in) N/A Landing Width (in) N/A N/A **DWS Contrast?** N/A N/A N/A N/A Landing Slope (%) DWS Length (in) N/A N/A Landing X Slope (%) N/A N/A DWS Full Width? N/A N/A Landing Curb? (Y/N) N/A N/A DWS Offset (in) N/A N/A N/A Shared Landing? N/A **Gutter Ponding?** N/A N/A Gutter Slope (%) N/A N/A Gutter Lip Ht (in) N/A N/A Gutter X Slope (%) N/A N/A Painted X Walk1? No N/A Painted X Walk2? No X Walk 1 Direction To S X Walk 2 Direction To W N/A N/A X Walk 1 Width (in) X Walk 2 Width (in) N/A X Walk 1 Slope (%) 0.7 X Walk 2 Slope (%) 0.8 X Walk 2 X Slope (%) X Walk 1 X Slope (%) 1.1 3.4 N/A N/A N/A Ramp inside XWalk2? N/A Ramp inside XWalk1? Road Slope (%) 0.1 N/A Clear Space? N/A N/A Road X Slope (%) 5.1 Clear Space to XWalk (in) N/A N/A N/A N/A Any Obstructions? Storm Grate/Utility Hazard? N/A

Remove & Replace Curb Ramp With Two New Directional Ramps or Equivalent.
