# Access Compliance Report

## Public Rights-of-Way

Intersection ID: 45487	Main Street: WADE_ARDREY_RD	Cross Street: CAPTAIN_ARDREY_RD	Location: SE
ADA ID: 6BA3A4C66976	Ramp Type: PerpDiag	Initial Pass/Fail: Fail	Overall Compliance: No
Severity Score: 10			
Codes/Mitigation Info/Possible Solution		Field Measurements/Component Compliance

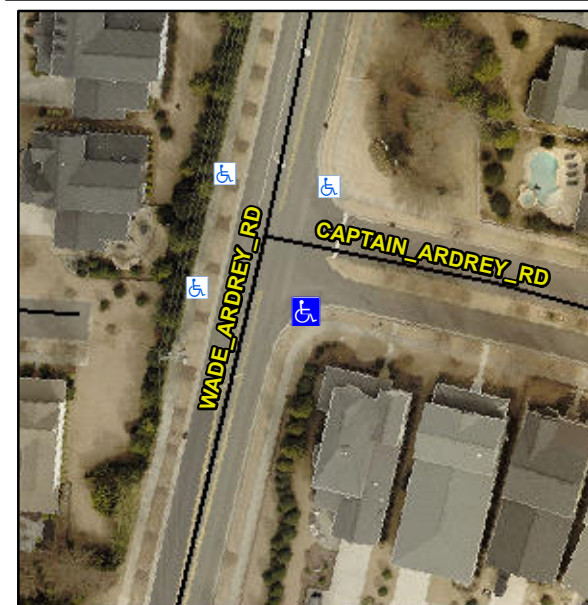
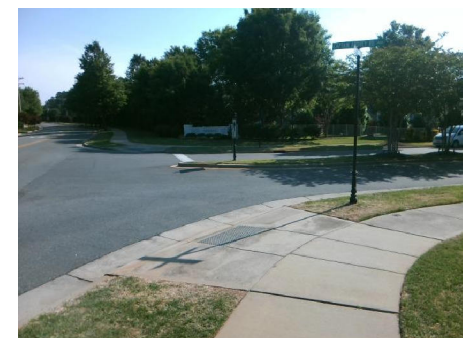
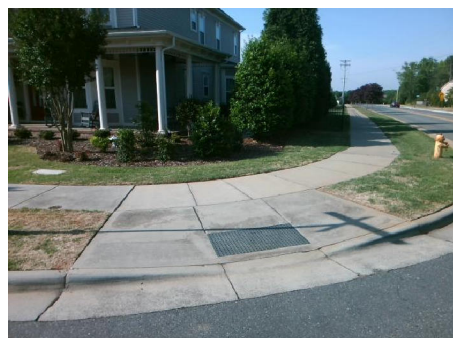
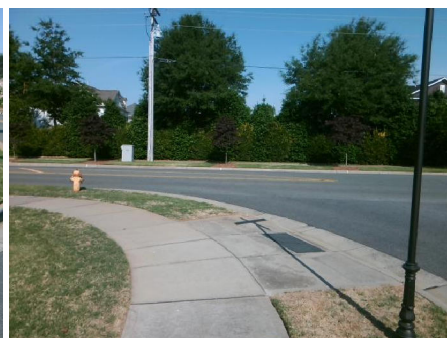
**Not Found, R304.5.1, R304.5.3**

Compliance	Description	Data	Compliance	Description	Data
N/A	Ramp Length (in)	72.0	Yes	Ramp Slope (%)	7.9
No	Ramp Width (in)	47.0	No	Ramp XSlope (%)	2.1
N/A	Flare Type LT	N/A	N/A	Flare Type RT	N/A
N/A	Flare Slope LT (%)	N/A	N/A	Flare Slope RT (%)	N/A
N/A	Flare Traversable LT?	N/A	N/A	Flare Traversable RT?	N/A
N/A	Landing Length (in)	N/A	N/A	DWS Provided?	N/A
N/A	Landing Width (in)	N/A	N/A	DWS Contrast?	N/A
N/A	Landing Slope (%)	N/A	N/A	DWS Length (in)	N/A
N/A	Landing X Slope (%)	N/A	N/A	DWS Full Width?	N/A
N/A	Landing Curb? (Y/N)	N/A	N/A	DWS Offset (in)	N/A
N/A	Shared Landing?	N/A			
N/A	Gutter Ponding?	N/A	N/A	Gutter Slope (%)	N/A
N/A	Gutter Lip Ht (in)	N/A	N/A	Gutter X Slope (%)	N/A
N/A	Painted X Walk1?	No	N/A	Painted X Walk2?	No
	X Walk 1 Direction	To NE		X Walk 2 Direction	To NW
N/A	X Walk 1 Width (in)	N/A	N/A	X Walk 2 Width (in)	N/A
	X Walk 1 Slope (%)	0.7		X Walk 2 Slope (%)	1.6
	X Walk 1 X Slope (%)	1.6		X Walk 2 X Slope (%)	0.2

N/A	Ramp inside XWalk1?	N/A	N/A	Ramp inside XWalk2?	N/A
	Road Slope (%)	1.4	N/A	Clear Space?	N/A
	Road X Slope (%)	3.0	N/A	Clear Space to XWalk (in)	N/A
N/A	Any Obstructions?	N/A	N/A	Storm Grate/Utility Hazard?	N/A
	Obstruction Type			Storm Grate/Utility Type	
		N/A			N/A
		Yes		Surface Condition? (G/P)	Good

**Remove & Replace Curb Ramp With Two New Directional Ramps or Equivalent.**
