Access Compliance Report

Public Rights-of-Way

(Curb Ramps)

Intersection ID: 12433	Main Street: WILKINSON_BV	Cross Street: MIDLAND_AV	Location: NW
ADA ID: 6BA625CDED85	Ramp Type: ParaDiag	Initial Pass/Fail: Fail	Overall Compliance: No
		Severity Score: 12.5

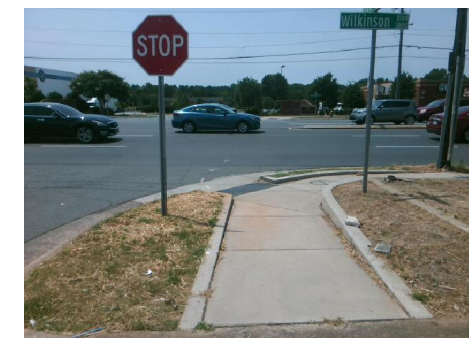
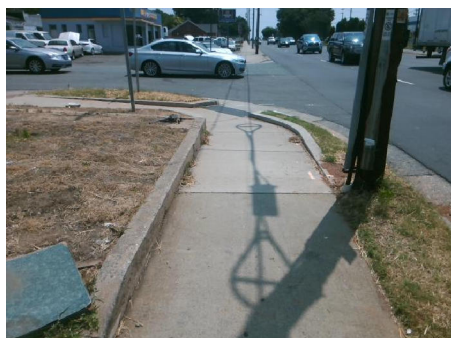
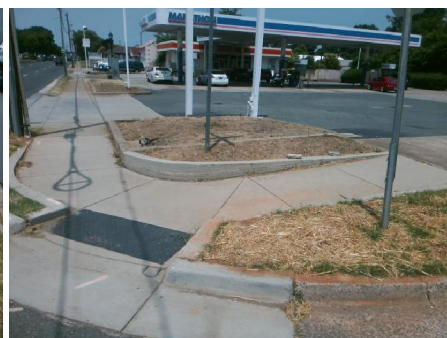
LT RP < 5%

Compliance	Description	Data	Compliance	Description	Data
N/A	Ramp Length LT (in)	32.0	N/A	Ramp Length RT (in)	115.0
Yes	Ramp Width LT (in)	58.0	Yes	Ramp Width RT (in)	59.0
Yes	Ramp Slope LT (%)	3.2	No	Ramp Slope RT (%)	8.6
Yes	Ramp XSlope LT (%)	2.0	Yes	Ramp XSlope RT (%)	0.2
N/A	Landing Length (in)	N/A	N/A	DWS Provided?	N/A
N/A	Landing Width (in)	N/A	N/A	DWS Contrast?	N/A
N/A	Landing Slope (%)	N/A	N/A	DWS Length (in)	N/A
N/A	Landing X Slope (%)	N/A	N/A	DWS Full Width?	N/A
N/A	Landing Curb? (Y/N)	N/A	N/A	DWS Offset (in)	N/A
N/A	Shared Landing?	N/A			
N/A	Gutter Ponding?	N/A	N/A	Gutter Slope (%)	N/A
N/A	Gutter Lip Ht (in)	N/A	N/A	Gutter X Slope (%)	N/A
N/A	Painted X Walk1?	No	N/A	Painted X Walk2?	No
	X Walk 1 Direction	To S		X Walk 2 Direction	To E
N/A	X Walk 1 Width (in)	N/A	N/A	X Walk 2 Width (in)	N/A
	X Walk 1 Slope (%)	2.1		X Walk 2 Slope (%)	5.3
	X Walk 1 X Slope (%)	2.7		X Walk 2 X Slope (%)	0.4
N/A	Ramp inside XWalk1?	N/A	N/A	Ramp inside XWalk2?	N/A

Road Slope (%)	2.6	N/A	Clear Space?	N/A
	Road X Slope (%)	3.7	N/A	Clear Space to XWalk (in)	N/A
N/A	Any Obstructions?	N/A	N/A	Storm Grate/Utility Hazard?	N/A
	Obstruction Type			Storm Grate/Utility Type	
		N/A			N/A
			Yes	Surface Condition? (G/P)	Good
			N/A	Curb Slope (%)	1.0

Possible Solutions:

Remove & Replace Curb Ramp With Two New Directional Ramps or Equivalent.
