Access Compliance Report

Public Rights-of-Way

(Curb Ramps)

Intersection ID: 12695	Main Street: S_CALDWELL_ST	Cross Street: E TRADE ST	Location: E
ADA ID: 6BABF16206C3	Ramp Type: Perp	Initial Pass/Fail: Fail	Overall Compliance: No
Severity Score: 12.5			
Codes/Mitigation Info/Possible Solution		Field Measurements/Component Compliance

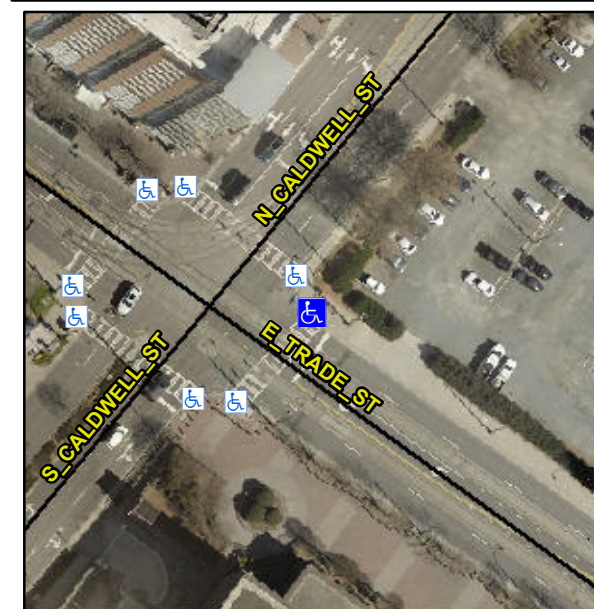
R304.2.2

Compliance	Description	Data	Compliance	Description	Data
N/A	Ramp Length (in)	72.0	No	Ramp Slope (%)	8.4
Yes	Ramp Width (in)	48.0	Yes	Ramp XSlope (%)	1.3
N/A	Flare Type LT	N/A	N/A	Flare Type RT	N/A
N/A	Flare Slope LT (%)	N/A	N/A	Flare Slope RT (%)	N/A
N/A	Flare Traversable LT?	N/A	N/A	Flare Traversable RT?	N/A
N/A	Landing Length (in)	N/A	N/A	DWS Provided?	N/A
N/A	Landing Width (in)	N/A	N/A	DWS Contrast?	N/A
N/A	Landing Slope (%)	N/A	N/A	DWS Length (in)	N/A
N/A	Landing X Slope (%)	N/A	N/A	DWS Full Width?	N/A
N/A	Landing Curb? (Y/N)	N/A	N/A	DWS Offset (in)	N/A
N/A	Shared Landing?	N/A			
N/A	Gutter Ponding?	N/A	N/A	Gutter Slope (%)	N/A
N/A	Gutter Lip Ht (in)	N/A	N/A	Gutter X Slope (%)	N/A
N/A	Painted X Walk1?	Yes	N/A	Painted X Walk2?	N/A
	X Walk 1 Direction	To SW		X Walk 2 Direction	N/A
N/A	X Walk 1 Width (in)	121.0	N/A	X Walk 2 Width (in)	N/A
	X Walk 1 Slope (%)	3.1		X Walk 2 Slope (%)	N/A
	X Walk 1 X Slope (%)	0.2		X Walk 2 X Slope (%)	N/A

N/A	Ramp inside XWalk1?	Yes	N/A	Ramp inside XWalk2?	N/A
	Road Slope (%)	N/A	N/A	Clear Space?	N/A
	Road X Slope (%)	N/A	N/A	Clear Space to XWalk (in)	N/A
N/A	Any Obstructions?	N/A	N/A	Storm Grate/Utility Hazard?	N/A
	Obstruction Type			Storm Grate/Utility Type	
		N/A			N/A
		Yes		Surface Condition? (G/P)	Good

Remove & Replace Entire Ramp.

Total Cost: \$ 1850.00
