# Access Compliance Report

## Public Rights-of-Way

| Intersection ID: 19960 | Main Street: ARCHDALE_DR | Cross Street: NETHERWOOD_DR | Location: NE |
| ADA ID: 6BAC808F562E | Ramp Type: PerpDiag | Initial Pass/Fail: Fail | Overall Compliance: No |

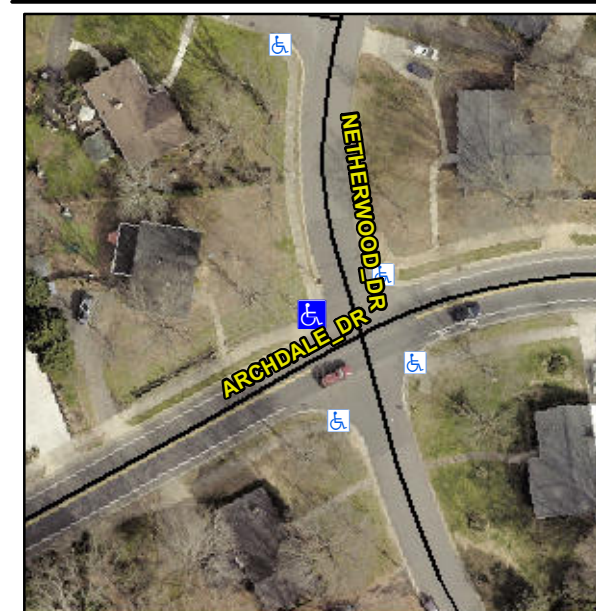
**Not Found, R304.5.1, R304.5.3**

| Compliance | Description | Data | Compliance | Description | Data |
|---|---|---|---|---|---|
| N/A | Ramp Length (in) | 71.0 | Yes | Ramp Slope (%) | 6.8 |
| No | Ramp Width (in) | 41.5 | No | Ramp XSlope (%) | 5.1 |

**Remove & Replace Curb Ramp With Two New Directional Ramps or Equivalent.**
