Access Compliance Report

Public Rights-of-Way

(Curb Ramps)

Intersection ID: 45133	Main Street: SATTERFIELD_CT	Cross Street: LITTLE_WHITEOAK_RD	Location: NW
ADA ID: 6BACE89660C7	Ramp Type: Perp	Initial Pass/Fail: Fail	Overall Compliance: No
Severity Score: 10			
Codes/Mitigation Info/Possible Solution		Field Measurements/Component Compliance

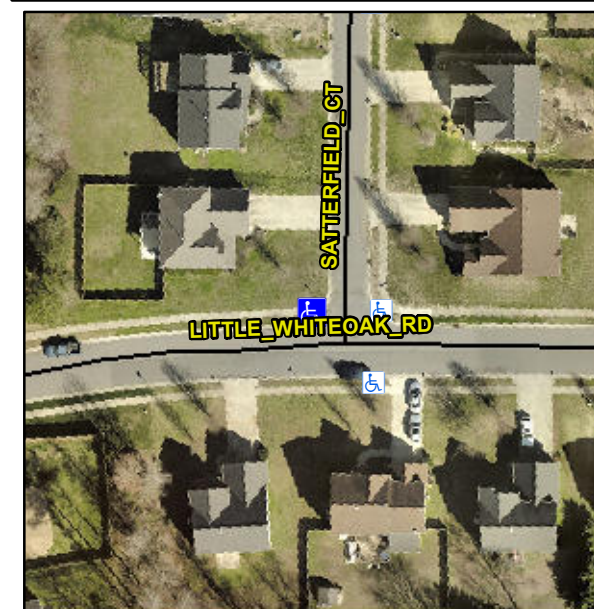
Not Found, R304.5.1, R304.5.3

Compliance	Description	Data	Compliance	Description	Data
N/A	Ramp Length (in)	51.0	Yes	Ramp Slope (%)	7.5
No	Ramp Width (in)	37.5	No	Ramp XSlope (%)	2.5
N/A	Flare Type LT	N/A	N/A	Flare Type RT	N/A
N/A	Flare Slope LT (%)	N/A	N/A	Flare Slope RT (%)	N/A
N/A	Flare Traversable LT?	N/A	N/A	Flare Traversable RT?	N/A
N/A	Landing Length (in)	N/A	N/A	DWS Provided?	N/A
N/A	Landing Width (in)	N/A	N/A	DWS Contrast?	N/A
N/A	Landing Slope (%)	N/A	N/A	DWS Length (in)	N/A
N/A	Landing X Slope (%)	N/A	N/A	DWS Full Width?	N/A
N/A	Landing Curb? (Y/N)	N/A	N/A	DWS Offset (in)	N/A
N/A	Shared Landing?	N/A			
N/A	Gutter Ponding?	N/A	N/A	Gutter Slope (%)	N/A
N/A	Gutter Lip Ht (in)	N/A	N/A	Gutter X Slope (%)	N/A
N/A	Painted X Walk1?	No	N/A	Painted X Walk2?	N/A
	X Walk 1 Direction	To E		X Walk 2 Direction	N/A
N/A	X Walk 1 Width (in)	N/A	N/A	X Walk 2 Width (in)	N/A
	X Walk 1 Slope (%)	0.2		X Walk 2 Slope (%)	N/A
	X Walk 1 X Slope (%)	1.2		X Walk 2 X Slope (%)	N/A

N/A	Ramp inside XWalk1?	N/A	N/A	Ramp inside XWalk2?	N/A
	Road Slope (%)	N/A	N/A	Clear Space?	N/A
	Road X Slope (%)	N/A	N/A	Clear Space to XWalk (in)	N/A
N/A	Any Obstructions?	N/A	N/A	Storm Grate/Utility Hazard?	N/A
	Obstruction Type			Storm Grate/Utility Type	
		N/A			N/A
			Yes	Surface Condition? (G/P)	Good

Possible Solutions:

Remove & Replace Entire Ramp.

Total Cost: \$ 1850.00
