Access Compliance Report

Public Rights-of-Way

(Curb Ramps)

Intersection ID: N/A	Main Street: KIRKWYND COMMONS DR	Cross Street: BRECKFIELD CT	Location: SW
ADA ID: 6BADD705BA5B	Ramp Type: PerpDiag	Initial Pass/Fail: Fail	Overall Compliance: No
Severity Score: 12.5			
Codes/Mitigation Info/Possible Solution		Field Measurements/Component Compliance

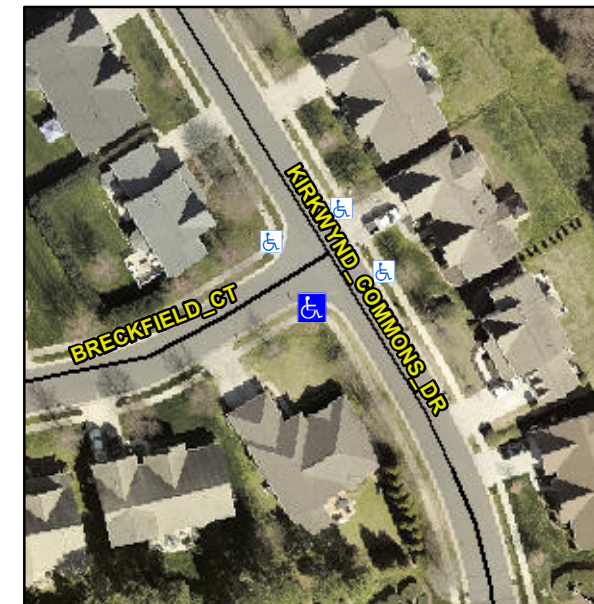
Compliance	Description	Data	Compliance	Description	Data
N/A	Ramp Length (in)	47.0	No	Ramp Slope (%)	10.0
Yes	Ramp Width (in)	48.0	Yes	Ramp XSlope (%)	1.8
N/A	Flare Type LT	N/A	N/A	Flare Type RT	N/A
N/A	Flare Slope LT (%)	N/A	N/A	Flare Slope RT (%)	N/A
N/A	Flare Traversable LT?	N/A	N/A	Flare Traversable RT?	N/A
N/A	Landing Length (in)	N/A	N/A	DWS Provided?	N/A
N/A	Landing Width (in)	N/A	N/A	DWS Contrast?	N/A
N/A	Landing Slope (%)	N/A	N/A	DWS Length (in)	N/A
N/A	Landing X Slope (%)	N/A	N/A	DWS Full Width?	N/A
N/A	Landing Curb? (Y/N)	N/A	N/A	DWS Offset (in)	N/A
N/A	Shared Landing?	N/A			
N/A	Gutter Ponding?	N/A	N/A	Gutter Slope (%)	N/A
N/A	Gutter Lip Ht (in)	N/A	N/A	Gutter X Slope (%)	N/A
N/A	Painted X Walk1?	No	N/A	Painted X Walk2?	No
	X Walk 1 Direction	To NE		X Walk 2 Direction	To NW
N/A	X Walk 1 Width (in)	N/A	N/A	X Walk 2 Width (in)	N/A
	X Walk 1 Slope (%)	0.9		X Walk 2 Slope (%)	2.9
	X Walk 1 X Slope (%)	2.0		X Walk 2 X Slope (%)	0.8

N/A	Ramp inside XWalk1?	N/A	N/A	Ramp inside XWalk2?	N/A
	Road Slope (%)	0.9	N/A	Clear Space?	N/A
	Road X Slope (%)	2.0	N/A	Clear Space to XWalk (in)	N/A
N/A	Any Obstructions?	N/A	N/A	Storm Grate/Utility Hazard?	N/A
	Obstruction Type			Storm Grate/Utility Type	
		N/A			N/A
			Yes	Surface Condition? (G/P)	Good

Possible Solutions:

Remove & Replace Curb Ramp With Two New Directional Ramps or Equivalent.

R304.2.2
