Access Compliance Report

Public Rights-of-Way

(Curb Ramps)

Intersection ID: 19216	Main Street: RAMA_RD	Cross Street: SARDIS_RD	Location: SW
ADA ID: 6BB4223DA3FB	Ramp Type: IslandPerp	Initial Pass/Fail: Fail	Overall Compliance: No
		Severity Score: 10

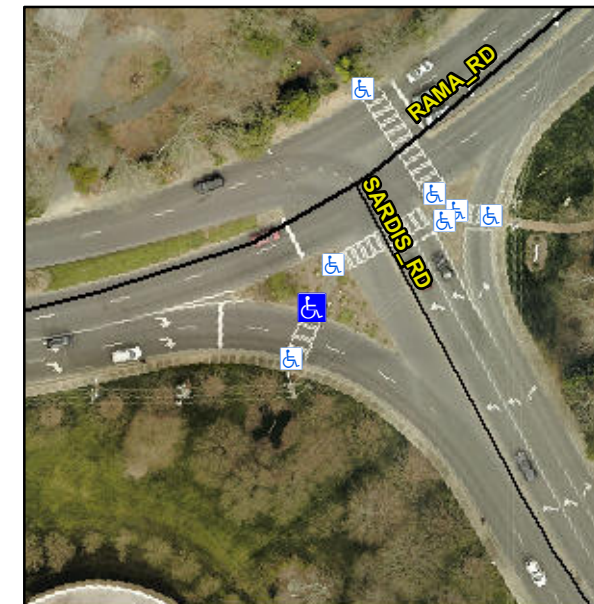
Not Found, R304.5.1, R304.5.3

Compliance	Description	Data	Compliance	Description	Data
N/A	Ramp Length (in)	55.5	Yes	Ramp Slope (%)	2.2
No	Ramp Width (in)	45.0	No	Ramp XSlope (%)	2.3
N/A	Flare Type LT	N/A	N/A	Flare Type RT	N/A
N/A	Flare Slope LT (%)	N/A	N/A	Flare Slope RT (%)	N/A
N/A	Flare Traversable LT?	N/A	N/A	Flare Traversable RT?	N/A
N/A	Landing Length (in)	N/A	N/A	DWS Provided?	N/A
N/A	Landing Width (in)	N/A	N/A	DWS Contrast?	N/A
N/A	Landing Slope (%)	N/A	N/A	DWS Length (in)	N/A
N/A	Landing X Slope (%)	N/A	N/A	DWS Full Width?	N/A
N/A	Landing Curb? (Y/N)	N/A	N/A	DWS Offset (in)	N/A
N/A	Shared Landing?	N/A			
N/A	Gutter Ponding?	N/A	N/A	Gutter Slope (%)	N/A
N/A	Gutter Lip Ht (in)	N/A	N/A	Gutter X Slope (%)	N/A
N/A	Painted X Walk1?	Yes	N/A	Painted X Walk2?	N/A
	X Walk 1 Direction	To SW		X Walk 2 Direction	N/A
N/A	X Walk 1 Width (in)	110.0	N/A	X Walk 2 Width (in)	N/A
	X Walk 1 Slope (%)	1.9		X Walk 2 Slope (%)	N/A
	X Walk 1 X Slope (%)	0.3		X Walk 2 X Slope (%)	N/A

N/A	Ramp inside XWalk1?	Yes	N/A	Ramp inside XWalk2?	N/A
	Road Slope (%)	N/A	N/A	Clear Space?	N/A
	Road X Slope (%)	N/A	N/A	Clear Space to XWalk (in)	N/A
N/A	Any Obstructions?	N/A	N/A	Storm Grate/Utility Hazard?	N/A
	Obstruction Type			Storm Grate/Utility Type	
		N/A			N/A
			Yes	Surface Condition? (G/P)	Good

Remove & Replace Entire Ramp.

Total Cost: \$ 3400.00
