# Access Compliance Report

## Public Rights-of-Way (Curb Ramps)

| Intersection ID: 10031808 | Main Street: MILLENNIUM_AV | Cross Street: N/A | Location: | N |
| ADA ID: 6BB64E8484E6 | Ramp Type: Directional1 | Initial Pass/Fail: Pass | Overall Compliance: No | Severity Score: 5.25 |

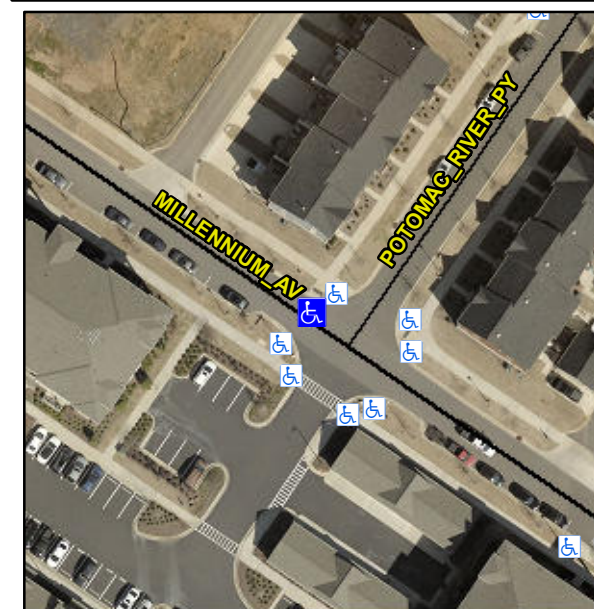
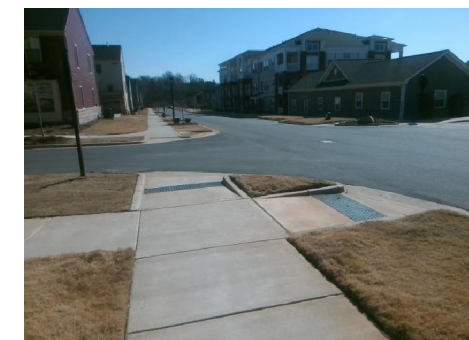
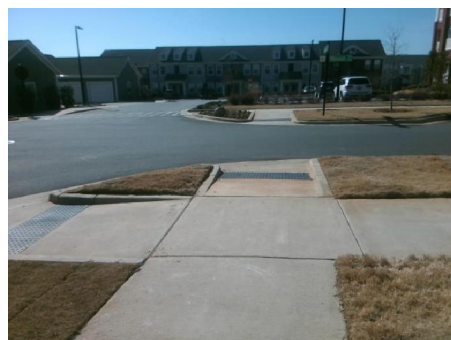
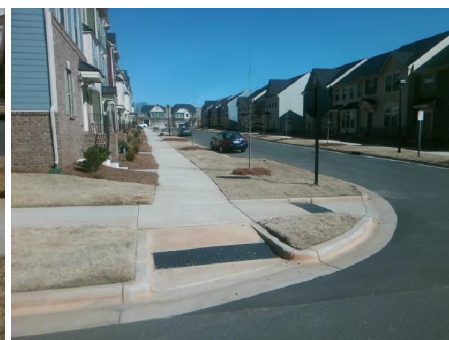
| Compliance | Description | Data | Compliance | Description | Data |
|---|---|---|---|---|---|
| No | Ramp XSlope (%) | 2.9 | | | |
| No | Landing X Slope (%) | 2.4 | Yes | DWS Full Width? | Yes |
| N/A | Shared Landing? | Yes | No | DWS Offset RT (in) | 7.0 |
| Yes | Gutter Ponding? | No | No | Gutter Slope (%) | 8.3 |

**Remove & Replace Entire Ramp.  
Remove & Replace Gutter.**

**R304.5.3, R305.2, R304.5.4**
