Access Compliance Report Public Rights-of-Way (Curb Ramps)

Intersection ID: 42550 Main Street: ENEIDA SUE DR **Cross Street: JOANNAS CT** Location: N **Overall Compliance: No Severity Score:** ADA ID: 6BB8F74EDB6B Ramp Type: BlendTrans1 Initial Pass/Fail: Fail 8.75

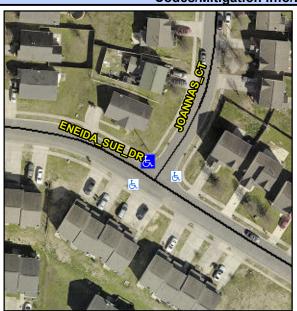
Total Cost: 3200.00 Compliance Description Data Compliance Description Data Yes N/A Ramp Length (in) 48.0 BlendTrans Slope (%) 2.3 Yes No Ramp Width (in) 37.5 BlendTrans XSlope (%) 1.9 N/A N/A Flare Type LT N/A Flare Type RT N/A N/A Flare Slope LT (%) N/A N/A Flare Slope RT (%) N/A N/A Flare Traversable LT? N/A N/A Flare Traversable RT? N/A N/A Landing Length (in) N/A N/A **DWS Provided?** N/A N/A Landing Width (in) N/A N/A **DWS Contrast?** N/A N/A N/A N/A Landing Slope (%) DWS Length (in) N/A N/A Landing X Slope (%) N/A N/A DWS Full Width? N/A N/A Landing Curb? (Y/N) N/A N/A DWS Offset (in) N/A N/A N/A Shared Landing? N/A **Gutter Ponding?** N/A N/A Gutter Slope (%) N/A N/A Gutter Lip Ht (in) N/A N/A Gutter X Slope (%) N/A N/A Painted X Walk1? No N/A Painted X Walk2? No X Walk 1 Direction To SW X Walk 2 Direction To SE N/A N/A X Walk 1 Width (in) X Walk 2 Width (in) X Walk 1 Slope (%) X Walk 2 Slope (%) 0.2 0.1 X Walk 1 X Slope (%) 2.2 X Walk 2 X Slope (%) 2.1 N/A N/A Ramp inside XWalk2? N/A N/A Ramp inside XWalk1? Road Slope (%) 2.8 Clear Space? N/A Road X Slope (%) N/A Clear Space to XWalk (in) N/A 1.6 N/A N/A N/A Any Obstructions? Storm Grate/Utility Hazard? N/A **Obstruction Type** Storm Grate/Utility Type N/A N/A Yes Surface Condition? (G/P) Good No 5.3 Curb Slope (%)

Possible Solutions: Remove & Replace Curb Ramp With Two New Directional Ramps or Equivalent. Surveyor Notes: N/A PROW/ADA: Not Found, R304.5.1
