Intersection ID: 18671	Main Street: BAKER_DR	Cross Street: SENECA_PL	Location:	SW
ADA ID: 6BB9E37FD37B	Ramp Type: PerpDiag	Initial Pass/Fail: Fail	Overall Compliance: No	Severity Score: 13.75

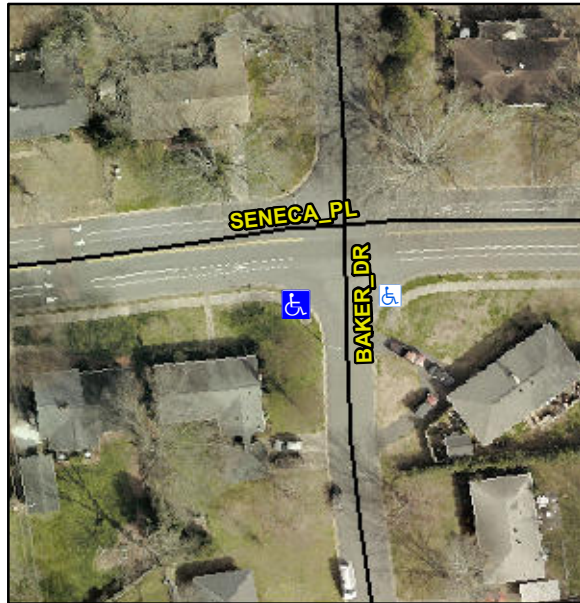
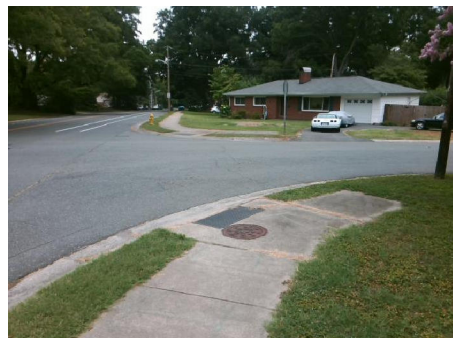
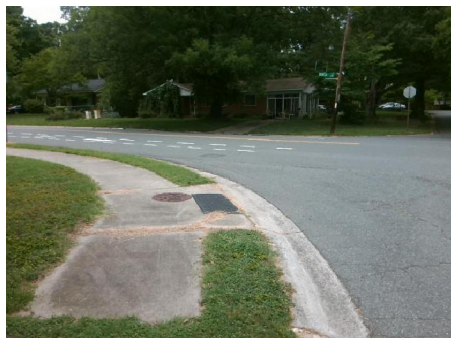
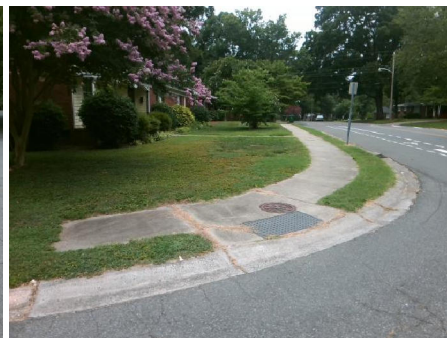
Not Found, R304.2.2, R304.5.3

Compliance	Description	Data	Compliance	Description	Data
N/A	Ramp Length (in)	26.0	No	Ramp Slope (%)	11.1
Yes	Ramp Width (in)	48.0	No	Ramp XSlope (%)	2.8
N/A	Flare Type LT	N/A	N/A	Flare Type RT	N/A
N/A	Flare Slope LT (%)	N/A	N/A	Flare Slope RT (%)	N/A
N/A	Flare Traversable LT?	N/A	N/A	Flare Traversable RT?	N/A
N/A	Landing Length (in)	N/A	N/A	DWS Provided?	N/A
N/A	Landing Width (in)	N/A	N/A	DWS Contrast?	N/A
N/A	Landing Slope (%)	N/A	N/A	DWS Length (in)	N/A
N/A	Landing X Slope (%)	N/A	N/A	DWS Full Width?	N/A
N/A	Landing Curb? (Y/N)	N/A	N/A	DWS Offset (in)	N/A
N/A	Shared Landing?	N/A			
N/A	Gutter Ponding?	N/A	N/A	Gutter Slope (%)	N/A
N/A	Gutter Lip Ht (in)	N/A	N/A	Gutter X Slope (%)	N/A
N/A	Painted X Walk1?	No	N/A	Painted X Walk2?	No
	X Walk 1 Direction	To E		X Walk 2 Direction	To N
N/A	X Walk 1 Width (in)	N/A	N/A	X Walk 2 Width (in)	N/A
	X Walk 1 Slope (%)	4.0		X Walk 2 Slope (%)	2.5
	X Walk 1 X Slope (%)	5.9		X Walk 2 X Slope (%)	0.9

N/A	Ramp inside XWalk1?	N/A	N/A	Ramp inside XWalk2?	N/A
	Road Slope (%)	4.0	N/A	Clear Space?	N/A
	Road X Slope (%)	5.7	N/A	Clear Space to XWalk (in)	N/A
N/A	Any Obstructions?	N/A	N/A	Storm Grate/Utility Hazard?	N/A
	Obstruction Type			Storm Grate/Utility Type	
		N/A			N/A
			Yes	Surface Condition? (G/P)	Good

Remove & Replace Curb Ramp With Two New Directional Ramps or Equivalent.
