## **Access Compliance Report Public Rights-of-Way** (Curb Ramps)

Intersection ID: 9676 Main Street: LUCENA ST **Cross Street: WOODWARD AV** Location: Ε **Overall Compliance: No** ADA ID: 6BBF72E1E414 Ramp Type: ParaDiag Initial Pass/Fail: Fail **Severity Score:** 0

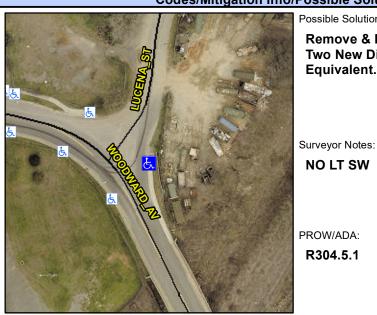
Compliance Description		Data	Comp	liance Description	Data
N/A	Ramp Length LT (in)	N/A	N/A	Ramp Length RT (in)	68.0
N/A	Ramp Width LT (in)	N/A	No	Ramp Width RT (in)	44.5
N/A	Ramp Slope LT (%)	N/A	Yes	Ramp Slope RT (%)	6.0
N/A	Ramp XSlope LT (%)	N/A	Yes	Ramp XSlope RT (%)	1.6
N/A	Landing Length (in)	N/A	N/A	DWS Provided?	N/A
N/A	Landing Width (in)	N/A	N/A	DWS Contrast?	N/A
N/A	Landing Slope (%)	N/A	N/A	DWS Length (in)	N/A
N/A	Landing X Slope (%)	N/A	N/A	DWS Full Width?	N/A
N/A	Landing Curb? (Y/N)	N/A	N/A	DWS Offset (in)	N/A
N/A	Shared Landing?	N/A			
N/A	Gutter Ponding?	Yes	N/A	Gutter Slope (%)	N/A
N/A	Gutter Lip Ht (in)	N/A	N/A	Gutter X Slope (%)	N/A
N/A	Painted X Walk1?	No	N/A	Painted X Walk2?	No
	X Walk 1 Direction	To NW		X Walk 2 Direction	To SW
N/A	X Walk 1 Width (in)	N/A	N/A	X Walk 2 Width (in)	N/A
	X Walk 1 Slope (%)	2.8		X Walk 2 Slope (%)	2.3
	X Walk 1 X Slope (%)	2.2		X Walk 2 X Slope (%)	4.2
N/A	Ramp inside XWalk1?	N/A	N/A	Ramp inside XWalk2?	N/A

Road Slope (%)	1.8	N/A	Clear Space?	N/A
	Road X Slope (%)	6.0	N/A	Clear Space to XWalk (in)	N/A
N/A	Any Obstructions?	N/A	N/A	Storm Grate/Utility Hazard?	N/A
	Obstruction Type			Storm Grate/Utility Type	
		N/A			N/A
			Yes	Surface Condition? (G/P)	Good
			N/A	Curb Slope (%)	N/A
	No. of the last of

**Two New Directional Ramps or** Equivalent.

**Remove & Replace Curb Ramp With**

R304.5.1

Total Cost: 3200.00
