Access Compliance Report

Public Rights-of-Way

(Curb Ramps)

Intersection ID: 48769	Main Street: KNOTHOLE_LN	Cross Street: SONOMA_VALLEY_DR	Location: SE
ADA ID: 6BC3AF09EAB3	Ramp Type: PerpDiag	Initial Pass/Fail: Fail	Overall Compliance: No
Severity Score: 8.75			
Codes/Mitigation Info/Possible Solution		Field Measurements/Component Compliance

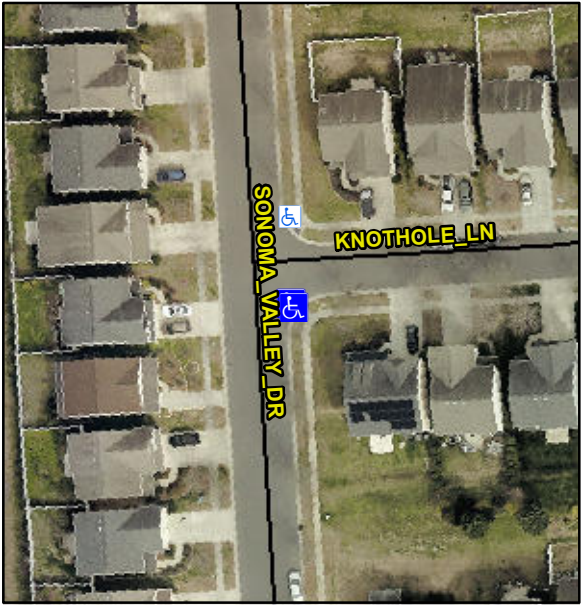
Possible Solutions:	Compliance	Description	Data	Compliance	Description	Data
	Remove & Replace Curb Ramp With Two New Directional Ramps or Equivalent.	N/A	Ramp Length (in)	72.0	Yes	Ramp Slope (%)	6.0
		No	Ramp Width (in)	47.0	Yes	Ramp XSlope (%)	1.3
		N/A	Flare Type LT	N/A	N/A	Flare Type RT	N/A
		N/A	Flare Slope LT (%)	N/A	N/A	Flare Slope RT (%)	N/A
		N/A	Flare Traversable LT?	N/A	N/A	Flare Traversable RT?	N/A
		N/A	Landing Length (in)	N/A	N/A	DWS Provided?	N/A
		N/A	Landing Width (in)	N/A	N/A	DWS Contrast?	N/A
		N/A	Landing Slope (%)	N/A	N/A	DWS Length (in)	N/A
		N/A	Landing X Slope (%)	N/A	N/A	DWS Full Width?	N/A
		N/A	Landing Curb? (Y/N)	N/A	N/A	DWS Offset (in)	N/A
		N/A	Shared Landing?	N/A			
		N/A	Gutter Ponding?	N/A	N/A	Gutter Slope (%)	N/A
		N/A	Gutter Lip Ht (in)	N/A	N/A	Gutter X Slope (%)	N/A
		N/A	Painted X Walk1?	No	N/A	Painted X Walk2?	No
			X Walk 1 Direction	To N		X Walk 2 Direction	To W

N/A	X Walk 1 Width (in)	N/A	N/A	X Walk 2 Width (in)	N/A
			X Walk 1 Slope (%)	2.2		X Walk 2 Slope (%)	1.3
			X Walk 1 X Slope (%)	0.5		X Walk 2 X Slope (%)	0.5
		N/A	Ramp inside XWalk1?	N/A	N/A	Ramp inside XWalk2?	N/A
<p>Surveyor Notes:</p> <p>N/A</p> <p>PROW/ADA:</p> <p>Not Found, R304.5.1</p>			Road Slope (%)	1.0	N/A	Clear Space?	N/A
			Road X Slope (%)	0.9	N/A	Clear Space to XWalk (in)	N/A
<p>Total Cost:</p> <p>\$ 3200.00</p>		N/A	Any Obstructions?	N/A	N/A	Storm Grate/Utility Hazard?	N/A
			Obstruction Type			Storm Grate/Utility Type	
				N/A			N/A
				Yes		Surface Condition? (G/P)	Good
