# Access Compliance Report

## Public Rights-of-Way

### (Curb Ramps)

Intersection ID: 3706	Main Street: PROSPERITY_CHURCH_RD	Cross Street: PROSPERITY_POINT_LN	Location: W
ADA ID: 6BC6472AE788	Ramp Type: Perp	Initial Pass/Fail: Fail	Overall Compliance: No
Severity Score: 1.25			
Codes/Mitigation Info/Possible Solution		Field Measurements/Component Compliance

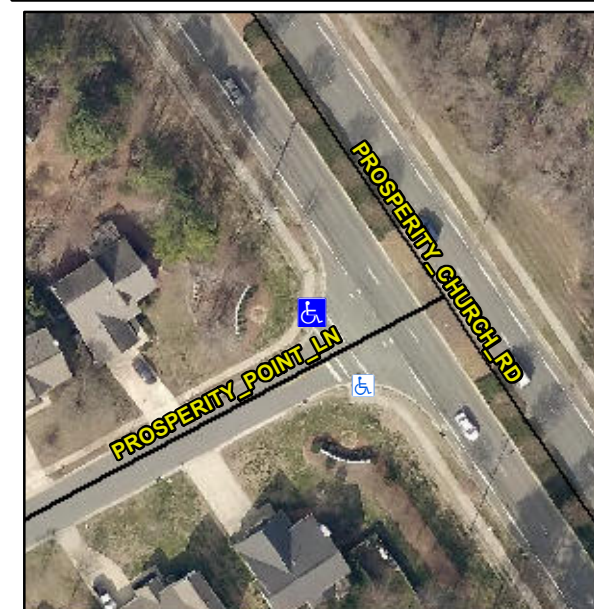
Compliance	Description	Data	Compliance	Description	Data
N/A	Ramp Length (in)	39.5	Yes	Ramp Slope (%)	7.7
Yes	Ramp Width (in)	51.5	No	Ramp XSlope (%)	3.5
N/A	Flare Type LT	N/A	N/A	Flare Type RT	N/A
N/A	Flare Slope LT (%)	N/A	N/A	Flare Slope RT (%)	N/A
N/A	Flare Traversable LT?	N/A	N/A	Flare Traversable RT?	N/A
N/A	Landing Length (in)	N/A	N/A	DWS Provided?	N/A
N/A	Landing Width (in)	N/A	N/A	DWS Contrast?	N/A
N/A	Landing Slope (%)	N/A	N/A	DWS Length (in)	N/A
N/A	Landing X Slope (%)	N/A	N/A	DWS Full Width?	N/A
N/A	Landing Curb? (Y/N)	N/A	N/A	DWS Offset (in)	N/A
N/A	Shared Landing?	N/A			
N/A	Gutter Ponding?	N/A	N/A	Gutter Slope (%)	N/A
N/A	Gutter Lip Ht (in)	N/A	N/A	Gutter X Slope (%)	N/A
N/A	Painted X Walk1?	Yes	N/A	Painted X Walk2?	N/A
	X Walk 1 Direction	To SE		X Walk 2 Direction	N/A
N/A	X Walk 1 Width (in)	120.0	N/A	X Walk 2 Width (in)	N/A
	X Walk 1 Slope (%)	1.3		X Walk 2 Slope (%)	N/A
	X Walk 1 X Slope (%)	4.0		X Walk 2 X Slope (%)	N/A

N/A	Ramp inside XWalk1?	Yes	N/A	Ramp inside XWalk2?	N/A
	Road Slope (%)	N/A	N/A	Clear Space?	N/A
	Road X Slope (%)	N/A	N/A	Clear Space to XWalk (in)	N/A
N/A	Any Obstructions?	N/A	N/A	Storm Grate/Utility Hazard?	N/A
	Obstruction Type			Storm Grate/Utility Type	
		N/A			N/A
		Yes		Surface Condition? (G/P)	Good

Possible Solutions:

**Remove & Replace Entire Ramp.**

**R304.5.3**

**\$ 1850.00**
