## **Access Compliance Report Public Rights-of-Way** (Curb Ramps)

Intersection ID: 9829 Main Street: CATALINA AV Cross Street: W 26TH ST Ε Location: Initial Pass/Fail: Fail **Overall Compliance: No Severity Score:** 70 ADA ID: 6BC70EDC34CC Ramp Type: Combination2

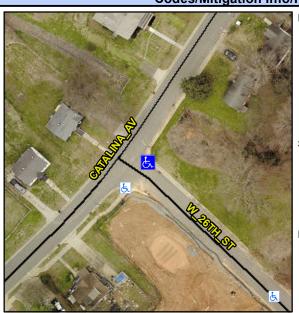
Street 1 Name StopSign Stop Condition-Street 1 **W 26TH ST** N/A Street 2 Name Stop Condition-Street 2 N/A Possible Solutions: Remove & Replace Entire Ramp. Surveyor Notes: NO CURB LINE, LT RP < 5% PROW/ADA: R304.5.1, R304.2.2, R304.3.2, R304.5.3, R302.7
