# Access Compliance Report

## Public Rights-of-Way

### (Curb Ramps)

| Intersection ID: 25654 | Main Street: REA_RD | Cross Street: STALLWORTH_DR | Location: SE |

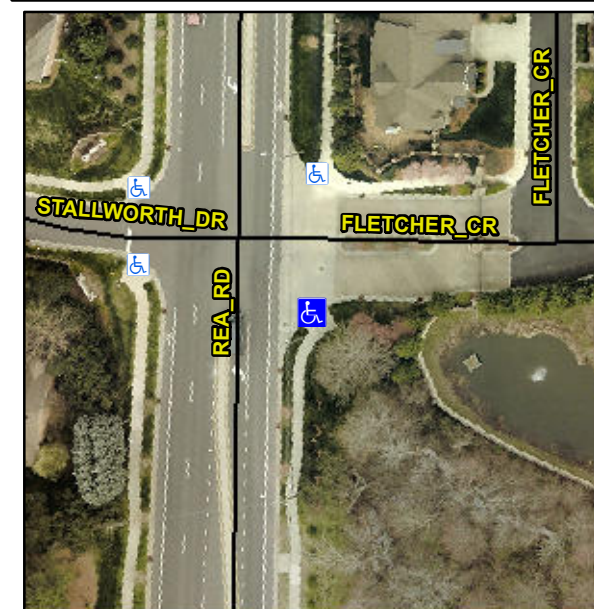
| Severity Score: 5 | | | |

**Not Found, R304.5.4**

| Compliance | Description | Data | Compliance | Description | Data |
|---|---|---|---|---|---|
| Yes | Gutter Ponding? | No | No | Gutter Slope (%) | 6.0 |

**Remove & Replace Curb Slope and Extend Ramp. Remove & Replace Gutter.**

Total Cost: \$ 2750.00
