Access Compliance Report

Public Rights-of-Way

(Curb Ramps)

Intersection ID: 13593	Main Street: MERRIMAN_AV	Cross Street: SPRUCE_ST	Location:	N
ADA ID: 6BD816B7104A	Ramp Type: BlendTrans1	Initial Pass/Fail: Fail	Overall Compliance: No	Severity Score: 1.25

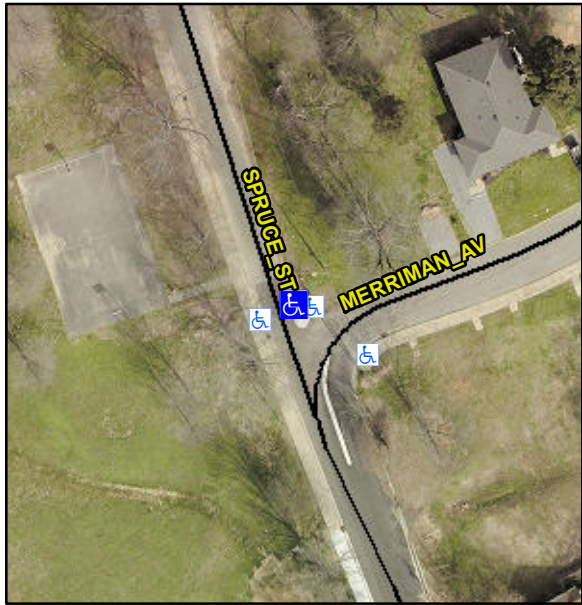
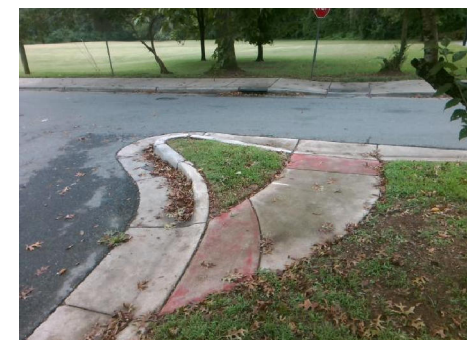
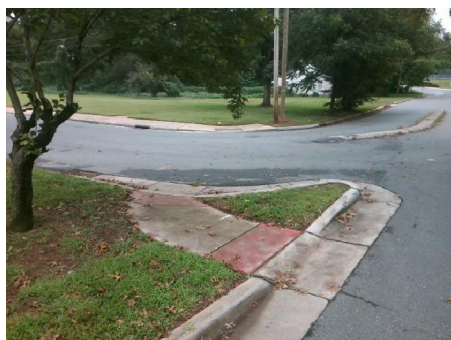
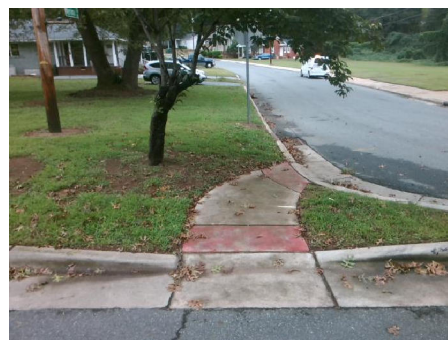
Possible Solutions:		Compliance	Description	Data	Compliance	Description	Data
	Remove & Replace Curb Ramp With Two New Directional Ramps or Equivalent.		N/A	Ramp Length (in)	23.0	Yes	BlendTrans Slope (%)	1.7
			Yes	Ramp Width (in)	48.0	No	BlendTrans XSlope (%)	2.5
			N/A	Flare Type LT	N/A	N/A	Flare Type RT	N/A
			N/A	Flare Slope LT (%)	N/A	N/A	Flare Slope RT (%)	N/A
			N/A	Flare Traversable LT?	N/A	N/A	Flare Traversable RT?	N/A
			N/A	Landing Length (in)	N/A	N/A	DWS Provided?	N/A
			N/A	Landing Width (in)	N/A	N/A	DWS Contrast?	N/A
			N/A	Landing Slope (%)	N/A	N/A	DWS Length (in)	N/A
			N/A	Landing X Slope (%)	N/A	N/A	DWS Full Width?	N/A
Surveyor Notes:		N/A	N/A	Landing Curb? (Y/N)	N/A	N/A	DWS Offset (in)	N/A
PROW/ADA:		Not Found, R304.5.3	N/A	Shared Landing?	N/A			
			N/A	Gutter Ponding?	N/A	N/A	Gutter Slope (%)	N/A

N/A	Gutter Lip Ht (in)	N/A	N/A	Gutter X Slope (%)	N/A
			N/A	Painted X Walk1?	No	N/A	Painted X Walk2?	N/A
				X Walk 1 Direction	To SW		X Walk 2 Direction	N/A
				X Walk 1 Width (in)	N/A		X Walk 2 Width (in)	N/A
				X Walk 1 Slope (%)	1.5		X Walk 2 Slope (%)	N/A
				X Walk 1 X Slope (%)	1.7		X Walk 2 X Slope (%)	N/A
			N/A	Ramp inside XWalk1?	N/A	N/A	Ramp inside XWalk2?	N/A
				Road Slope (%)	1.7		Clear Space?	N/A
				Road X Slope (%)	1.5	N/A	Clear Space to XWalk (in)	N/A
			N/A	Any Obstructions?	N/A	N/A	Storm Grate/Utility Hazard?	N/A
				Obstruction Type			Storm Grate/Utility Type	
					N/A			N/A
						Yes	Surface Condition? (G/P)	Good
						No	Curb Slope (%)	19.4
