Access Compliance Report

Public Rights-of-Way

(Curb Ramps)

Intersection ID: 3189	Main Street: SHELLY PINES DR	Cross Street: MALLARD WOODS PL	Location: SE
ADA ID: 6BE5E401DCC0	Ramp Type: Perp	Initial Pass/Fail: Fail	Overall Compliance: No
Severity Score: 13.75			
Codes/Mitigation Info/Possible Solution		Field Measurements/Component Compliance

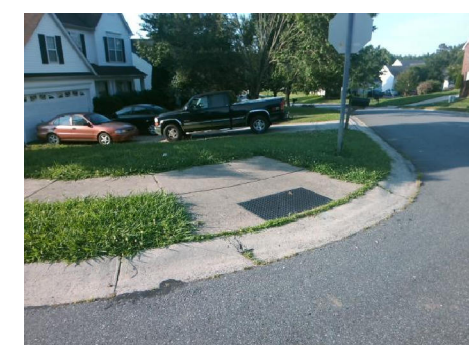
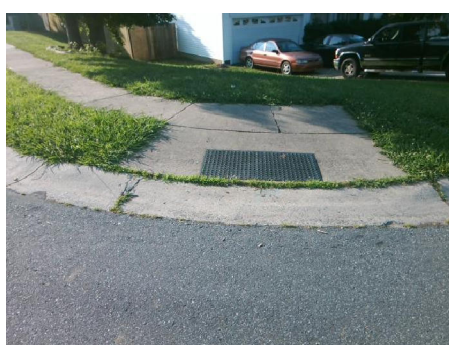
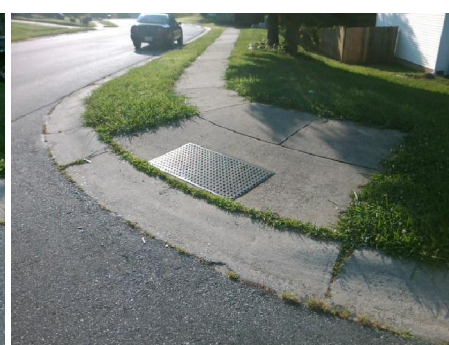
Compliance	Description	Data	Compliance	Description	Data
N/A	Ramp Length (in)	49.0	No	Ramp Slope (%)	8.5
Yes	Ramp Width (in)	65.0	No	Ramp XSlope (%)	3.3
N/A	Flare Type LT	N/A	N/A	Flare Type RT	N/A
N/A	Flare Slope LT (%)	N/A	N/A	Flare Slope RT (%)	N/A
N/A	Flare Traversable LT?	N/A	N/A	Flare Traversable RT?	N/A
N/A	Landing Length (in)	N/A	N/A	DWS Provided?	N/A
N/A	Landing Width (in)	N/A	N/A	DWS Contrast?	N/A
N/A	Landing Slope (%)	N/A	N/A	DWS Length (in)	N/A
N/A	Landing X Slope (%)	N/A	N/A	DWS Full Width?	N/A
N/A	Landing Curb? (Y/N)	N/A	N/A	DWS Offset (in)	N/A
N/A	Shared Landing?	N/A			
N/A	Gutter Ponding?	N/A	N/A	Gutter Slope (%)	N/A
N/A	Gutter Lip Ht (in)	N/A	N/A	Gutter X Slope (%)	N/A
N/A	Painted X Walk1?	No	N/A	Painted X Walk2?	N/A
	X Walk 1 Direction	To W		X Walk 2 Direction	N/A
N/A	X Walk 1 Width (in)	N/A	N/A	X Walk 2 Width (in)	N/A
	X Walk 1 Slope (%)	3.7		X Walk 2 Slope (%)	N/A
	X Walk 1 X Slope (%)	5.9		X Walk 2 X Slope (%)	N/A

N/A	Ramp inside XWalk1?	N/A	N/A	Ramp inside XWalk2?	N/A
	Road Slope (%)	N/A	N/A	Clear Space?	N/A
	Road X Slope (%)	N/A	N/A	Clear Space to XWalk (in)	N/A
N/A	Any Obstructions?	N/A	N/A	Storm Grate/Utility Hazard?	N/A
	Obstruction Type			Storm Grate/Utility Type	
		N/A			N/A
			Yes	Surface Condition? (G/P)	Good

Remove & Replace Entire Ramp.
