# Access Compliance Report

## Public Rights-of-Way

### (Curb Ramps)

Intersection ID: 5414	Main Street: BELLHAVEN_BV	Cross Street: LONG_CREEK_PY	Location: NW
ADA ID: 6BE748E4966D	Ramp Type: Perp	Initial Pass/Fail: Fail	Overall Compliance: No
Severity Score: 37.5			
Codes/Mitigation Info/Possible Solution		Field Measurements/Component Compliance

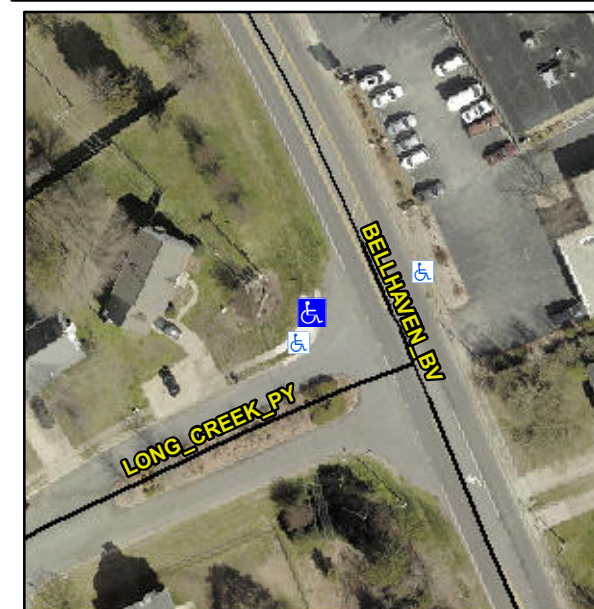
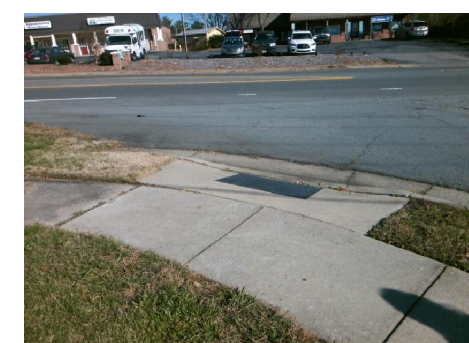
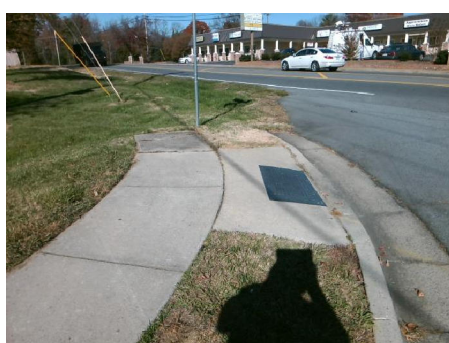
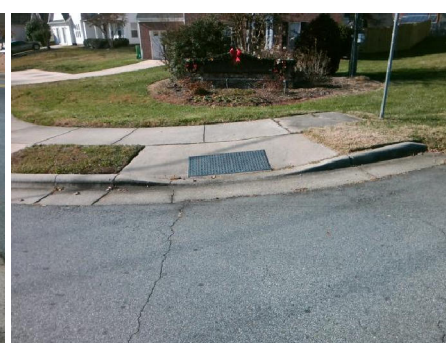
**Not Found, R304.2.2, R304.5.3**

Compliance	Description	Data	Compliance	Description	Data
N/A	Ramp Length (in)	47.0	No	Ramp Slope (%)	18.0
Yes	Ramp Width (in)	48.0	No	Ramp XSlope (%)	6.3
N/A	Flare Type LT	N/A	N/A	Flare Type RT	N/A
N/A	Flare Slope LT (%)	N/A	N/A	Flare Slope RT (%)	N/A
N/A	Flare Traversable LT?	N/A	N/A	Flare Traversable RT?	N/A
N/A	Landing Length (in)	N/A	N/A	DWS Provided?	N/A
N/A	Landing Width (in)	N/A	N/A	DWS Contrast?	N/A
N/A	Landing Slope (%)	N/A	N/A	DWS Length (in)	N/A
N/A	Landing X Slope (%)	N/A	N/A	DWS Full Width?	N/A
N/A	Landing Curb? (Y/N)	N/A	N/A	DWS Offset (in)	N/A
N/A	Shared Landing?	N/A			
N/A	Gutter Ponding?	N/A	N/A	Gutter Slope (%)	N/A
N/A	Gutter Lip Ht (in)	0.5	N/A	Gutter X Slope (%)	N/A
N/A	Painted X Walk1?	No	N/A	Painted X Walk2?	N/A
	X Walk 1 Direction	To NE		X Walk 2 Direction	N/A
N/A	X Walk 1 Width (in)	N/A	N/A	X Walk 2 Width (in)	N/A
	X Walk 1 Slope (%)	7.7		X Walk 2 Slope (%)	N/A
	X Walk 1 X Slope (%)	2.1		X Walk 2 X Slope (%)	N/A

N/A	Ramp inside XWalk1?	N/A	N/A	Ramp inside XWalk2?	N/A
	Road Slope (%)	N/A	N/A	Clear Space?	N/A
	Road X Slope (%)	N/A	N/A	Clear Space to XWalk (in)	N/A
N/A	Any Obstructions?	N/A	N/A	Storm Grate/Utility Hazard?	N/A
	Obstruction Type			Storm Grate/Utility Type	
		N/A			N/A
			Yes	Surface Condition? (G/P)	Good

**Remove & Replace Entire Ramp.**

Total Cost: \$ 1850.00
