Access Compliance Report

Public Rights-of-Way

(Curb Ramps)

Intersection ID: 10022357	Main Street: CAMERON_VALLEY_PY	Cross Street: N/A	Location: NW
ADA ID: 6C077FCEB7F2	Ramp Type: PerpDiag	Initial Pass/Fail: Fail	Overall Compliance: No
Severity Score: 10			
Codes/Mitigation Info/Possible Solution		Field Measurements/Component Compliance

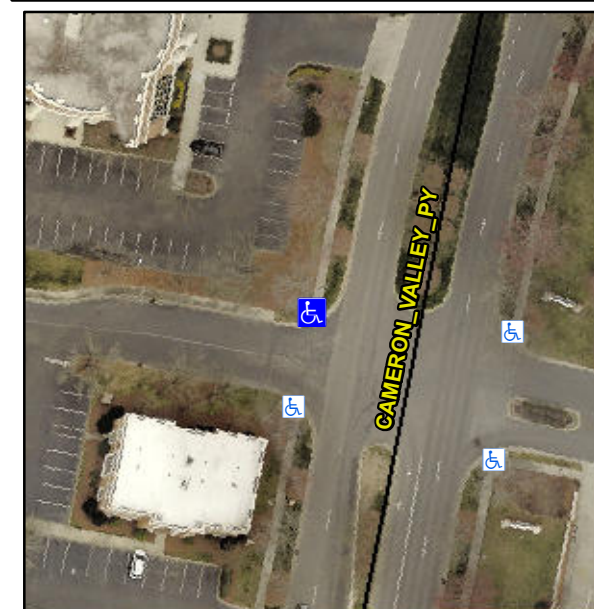
Not Found, R304.5.1, R304.5.3

Compliance	Description	Data	Compliance	Description	Data
N/A	Ramp Length (in)	48.0	Yes	Ramp Slope (%)	5.4
No	Ramp Width (in)	36.0	No	Ramp XSlope (%)	4.5
N/A	Flare Type LT	N/A	N/A	Flare Type RT	N/A
N/A	Flare Slope LT (%)	N/A	N/A	Flare Slope RT (%)	N/A
N/A	Flare Traversable LT?	N/A	N/A	Flare Traversable RT?	N/A
N/A	Landing Length (in)	N/A	N/A	DWS Provided?	N/A
N/A	Landing Width (in)	N/A	N/A	DWS Contrast?	N/A
N/A	Landing Slope (%)	N/A	N/A	DWS Length (in)	N/A
N/A	Landing X Slope (%)	N/A	N/A	DWS Full Width?	N/A
N/A	Landing Curb? (Y/N)	N/A	N/A	DWS Offset (in)	N/A
N/A	Shared Landing?	N/A			
N/A	Gutter Ponding?	N/A	N/A	Gutter Slope (%)	N/A
N/A	Gutter Lip Ht (in)	N/A	N/A	Gutter X Slope (%)	N/A
N/A	Painted X Walk1?	No	N/A	Painted X Walk2?	No
	X Walk 1 Direction	To SW		X Walk 2 Direction	To SE
N/A	X Walk 1 Width (in)	N/A	N/A	X Walk 2 Width (in)	N/A
	X Walk 1 Slope (%)	0.2		X Walk 2 Slope (%)	2.1
	X Walk 1 X Slope (%)	1.7		X Walk 2 X Slope (%)	1.3

Remove & Replace Curb Ramp With Two New Directional Ramps or Equivalent.

Total Cost: \$ 3200.00
