# Access Compliance Report

## Public Rights-of-Way

### (Curb Ramps)

Intersection ID: 10032188	Main Street: MORRISON_BV	Cross Street: N/A	Location: NE
ADA ID: 6C08B894CE61	Ramp Type: Perp	Initial Pass/Fail: Fail	Overall Compliance: No
Codes/Mitigation Info/Possible Solution		Field Measurements/Component Compliance	
Severity Score: 13.75

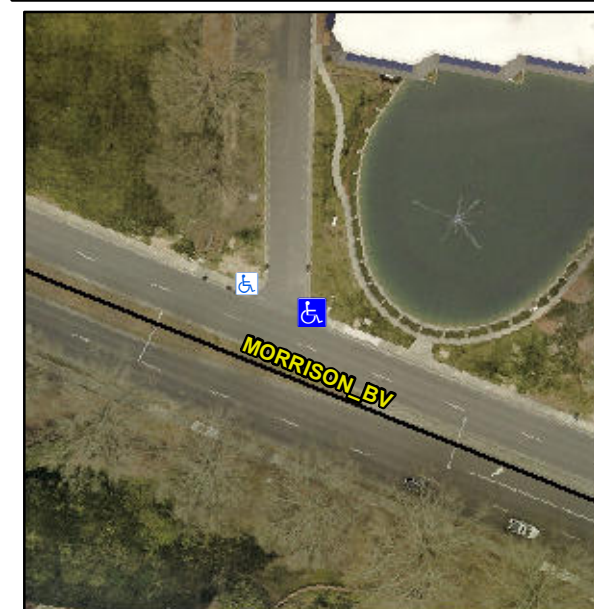
**Not Found, R304.2.2, R304.5.3**

Compliance	Description	Data	Compliance	Description	Data
N/A	Ramp Length (in)	48.0	No	Ramp Slope (%)	10.8
Yes	Ramp Width (in)	48.0	No	Ramp XSlope (%)	4.2
N/A	Flare Type LT	N/A	N/A	Flare Type RT	N/A
N/A	Flare Slope LT (%)	N/A	N/A	Flare Slope RT (%)	N/A
N/A	Flare Traversable LT?	N/A	N/A	Flare Traversable RT?	N/A
N/A	Landing Length (in)	N/A	N/A	DWS Provided?	N/A
N/A	Landing Width (in)	N/A	N/A	DWS Contrast?	N/A
N/A	Landing Slope (%)	N/A	N/A	DWS Length (in)	N/A
N/A	Landing X Slope (%)	N/A	N/A	DWS Full Width?	N/A
N/A	Landing Curb? (Y/N)	N/A	N/A	DWS Offset (in)	N/A
N/A	Shared Landing?	N/A			
N/A	Gutter Ponding?	N/A	N/A	Gutter Slope (%)	N/A
N/A	Gutter Lip Ht (in)	N/A	N/A	Gutter X Slope (%)	N/A
N/A	Painted X Walk1?	No	N/A	Painted X Walk2?	N/A
	X Walk 1 Direction	To NW		X Walk 2 Direction	N/A
N/A	X Walk 1 Width (in)	N/A	N/A	X Walk 2 Width (in)	N/A
	X Walk 1 Slope (%)	0.2		X Walk 2 Slope (%)	N/A
	X Walk 1 X Slope (%)	0.7		X Walk 2 X Slope (%)	N/A

N/A	Ramp inside XWalk1?	N/A	N/A	Ramp inside XWalk2?	N/A
	Road Slope (%)	N/A	N/A	Clear Space?	N/A
	Road X Slope (%)	N/A	N/A	Clear Space to XWalk (in)	N/A
N/A	Any Obstructions?	N/A	N/A	Storm Grate/Utility Hazard?	N/A
	Obstruction Type			Storm Grate/Utility Type	
		N/A			N/A
			Yes	Surface Condition? (G/P)	Good

**Remove & Replace Entire Ramp.**

Total Cost: \$ 1850.00
