Access Compliance Report

Public Rights-of-Way

(Curb Ramps)

Intersection ID: 14556	Main Street: E_WORTHINGTON_AV	Cross Street: WINTHROP_AV	Location: S
ADA ID: 6C0D31298601	Ramp Type: Perp	Initial Pass/Fail: Fail	Overall Compliance: No
		Severity Score: 1.25	
Codes/Mitigation Info/Possible Solution		Field Measurements/Component Compliance

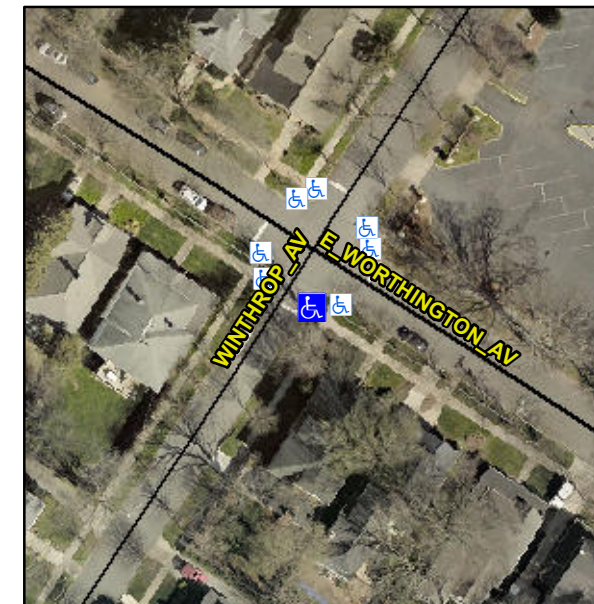
Not Found, R304.5.3

Compliance	Description	Data	Compliance	Description	Data
N/A	Ramp Length (in)	113.0	Yes	Ramp Slope (%)	7.3
Yes	Ramp Width (in)	59.0	No	Ramp XSlope (%)	4.4
N/A	Flare Type LT	N/A	N/A	Flare Type RT	N/A
N/A	Flare Slope LT (%)	N/A	N/A	Flare Slope RT (%)	N/A
N/A	Flare Traversable LT?	N/A	N/A	Flare Traversable RT?	N/A
N/A	Landing Length (in)	N/A	N/A	DWS Provided?	N/A
N/A	Landing Width (in)	N/A	N/A	DWS Contrast?	N/A
N/A	Landing Slope (%)	N/A	N/A	DWS Length (in)	N/A
N/A	Landing X Slope (%)	N/A	N/A	DWS Full Width?	N/A
N/A	Landing Curb? (Y/N)	N/A	N/A	DWS Offset (in)	N/A
N/A	Shared Landing?	N/A			
N/A	Gutter Ponding?	N/A	N/A	Gutter Slope (%)	N/A
N/A	Gutter Lip Ht (in)	N/A	N/A	Gutter X Slope (%)	N/A
N/A	Painted X Walk1?	No	N/A	Painted X Walk2?	N/A
	X Walk 1 Direction	To NW		X Walk 2 Direction	N/A
N/A	X Walk 1 Width (in)	N/A	N/A	X Walk 2 Width (in)	N/A
	X Walk 1 Slope (%)	5.4		X Walk 2 Slope (%)	N/A
	X Walk 1 X Slope (%)	4.5		X Walk 2 X Slope (%)	N/A

N/A	Ramp inside XWalk1?	N/A	N/A	Ramp inside XWalk2?	N/A
	Road Slope (%)	N/A	N/A	Clear Space?	N/A
	Road X Slope (%)	N/A	N/A	Clear Space to XWalk (in)	N/A
N/A	Any Obstructions?	N/A	N/A	Storm Grate/Utility Hazard?	N/A
	Obstruction Type			Storm Grate/Utility Type	
		N/A			N/A
			Yes	Surface Condition? (G/P)	Good

Remove & Replace Entire Ramp.

Total Cost: \$ 1850.00
