Access Compliance Report

Public Rights-of-Way

(Curb Ramps)

Intersection ID: 18346	Main Street: OLD_PINEVILLE_RD	Cross Street: MINUET_LN	Location: NW
ADA ID: 6C16919A5ED7	Ramp Type: ParaDiag	Initial Pass/Fail: Fail	Overall Compliance: No
			Severity Score: 13.75

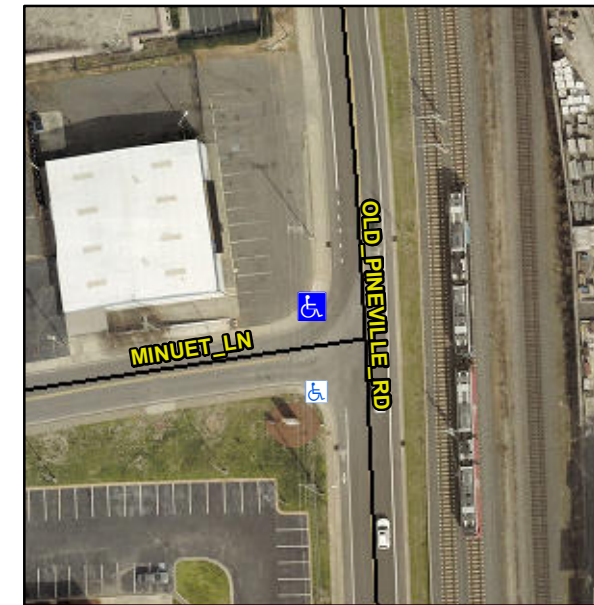
Compliance	Description	Data	Compliance	Description	Data
N/A	Ramp Length LT (in)	51.5	N/A	Ramp Length RT (in)	55.0
Yes	Ramp Width LT (in)	73.0	Yes	Ramp Width RT (in)	73.0
No	Ramp Slope LT (%)	8.4	Yes	Ramp Slope RT (%)	5.6
No	Ramp XSlope LT (%)	3.7	Yes	Ramp XSlope RT (%)	1.7
N/A	Landing Length (in)	N/A	N/A	DWS Provided?	N/A
N/A	Landing Width (in)	N/A	N/A	DWS Contrast?	N/A
N/A	Landing Slope (%)	N/A	N/A	DWS Length (in)	N/A
N/A	Landing X Slope (%)	N/A	N/A	DWS Full Width?	N/A
N/A	Landing Curb? (Y/N)	N/A	N/A	DWS Offset (in)	N/A
N/A	Shared Landing?	N/A			
N/A	Gutter Ponding?	N/A	N/A	Gutter Slope (%)	N/A
N/A	Gutter Lip Ht (in)	N/A	N/A	Gutter X Slope (%)	N/A
N/A	Painted X Walk1?	No	N/A	Painted X Walk2?	No
	X Walk 1 Direction	To S		X Walk 2 Direction	To E
N/A	X Walk 1 Width (in)	N/A	N/A	X Walk 2 Width (in)	N/A
	X Walk 1 Slope (%)	2.3		X Walk 2 Slope (%)	2.6
	X Walk 1 X Slope (%)	2.3		X Walk 2 X Slope (%)	1.5
N/A	Ramp inside XWalk1?	N/A	N/A	Ramp inside XWalk2?	N/A

Road Slope (%)	0.5	N/A	Clear Space?	N/A
	Road X Slope (%)	3.9	N/A	Clear Space to XWalk (in)	N/A
N/A	Any Obstructions?	N/A	N/A	Storm Grate/Utility Hazard?	N/A
	Obstruction Type			Storm Grate/Utility Type	
		N/A			N/A
			Yes	Surface Condition? (G/P)	Good
			N/A	Curb Slope (%)	10.7

Remove & Replace Curb Ramp With Two New Directional Ramps or Equivalent.
