Access Compliance Report

Public Rights-of-Way

(Curb Ramps)

Intersection ID: 3060	Main Street: BLACK_MAPLE_AV	Cross Street: BROWNE_RD	Location: NW
ADA ID: 6C35F1D2AFAF	Ramp Type: Perp	Initial Pass/Fail: Fail	Overall Compliance: No
Severity Score: 33.75			
Codes/Mitigation Info/Possible Solution		Field Measurements/Component Compliance

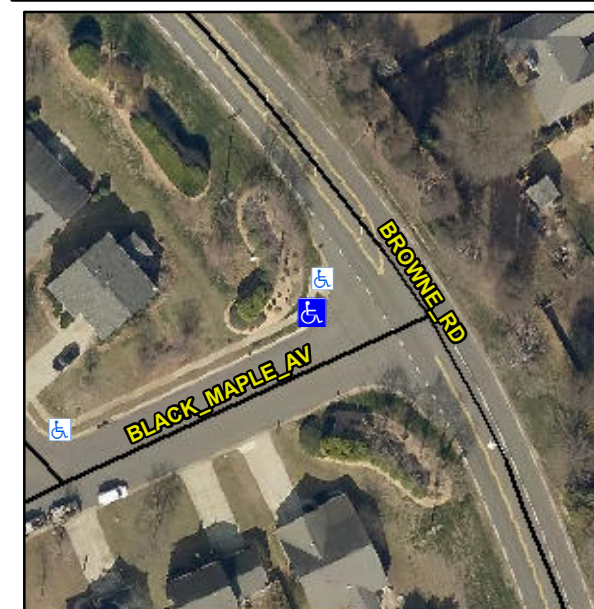
R304.5.1, R304.2.2

Compliance	Description	Data	Compliance	Description	Data
N/A	Ramp Length (in)	95.5	No	Ramp Slope (%)	18.5
No	Ramp Width (in)	37.0	Yes	Ramp XSlope (%)	1.0
N/A	Flare Type LT	N/A	N/A	Flare Type RT	N/A
N/A	Flare Slope LT (%)	N/A	N/A	Flare Slope RT (%)	N/A
N/A	Flare Traversable LT?	N/A	N/A	Flare Traversable RT?	N/A
N/A	Landing Length (in)	N/A	N/A	DWS Provided?	N/A
N/A	Landing Width (in)	N/A	N/A	DWS Contrast?	N/A
N/A	Landing Slope (%)	N/A	N/A	DWS Length (in)	N/A
N/A	Landing X Slope (%)	N/A	N/A	DWS Full Width?	N/A
N/A	Landing Curb? (Y/N)	N/A	N/A	DWS Offset (in)	N/A
N/A	Shared Landing?	N/A			
N/A	Gutter Ponding?	N/A	N/A	Gutter Slope (%)	N/A
N/A	Gutter Lip Ht (in)	N/A	N/A	Gutter X Slope (%)	N/A
N/A	Painted X Walk1?	No	N/A	Painted X Walk2?	N/A
	X Walk 1 Direction	To S		X Walk 2 Direction	N/A
N/A	X Walk 1 Width (in)	N/A	N/A	X Walk 2 Width (in)	N/A
	X Walk 1 Slope (%)	1.5		X Walk 2 Slope (%)	N/A
	X Walk 1 X Slope (%)	0.7		X Walk 2 X Slope (%)	N/A

N/A	Ramp inside XWalk1?	N/A	N/A	Ramp inside XWalk2?	N/A
	Road Slope (%)	N/A	N/A	Clear Space?	N/A
	Road X Slope (%)	N/A	N/A	Clear Space to XWalk (in)	N/A
N/A	Any Obstructions?	N/A	N/A	Storm Grate/Utility Hazard?	N/A
	Obstruction Type			Storm Grate/Utility Type	
		N/A			N/A
			Yes	Surface Condition? (G/P)	Good

Possible Solutions:

Remove & Replace Entire Ramp.

Total Cost: \$ 1850.00
