# Access Compliance Report

## Public Rights-of-Way

### (Curb Ramps)

Intersection ID: 52476	Main Street: WHITEHALL_EXECUTIVE_CENTER_DR	Cross Street: CERNY_DR	Location: NW
ADA ID: 6C48D65C117F	Ramp Type: Perp	Initial Pass/Fail: Fail	Overall Compliance: No
Severity Score: 13.75			
Codes/Mitigation Info/Possible Solution		Field Measurements/Component Compliance

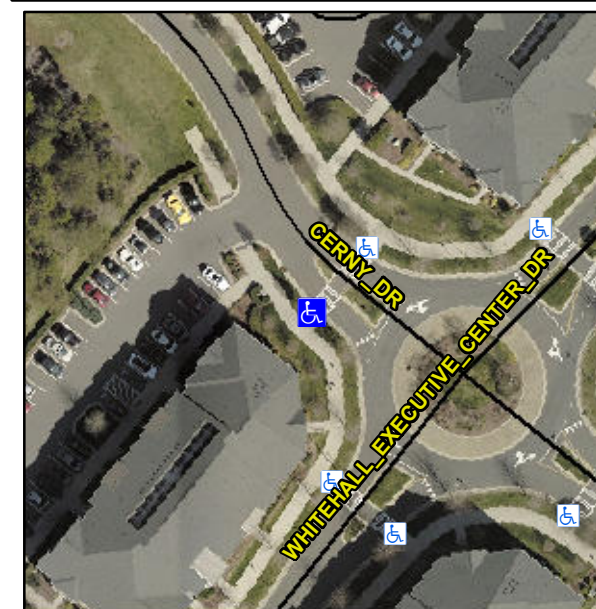
Compliance	Description	Data	Compliance	Description	Data
N/A	Ramp Length (in)	93.0	No	Ramp Slope (%)	8.9
Yes	Ramp Width (in)	96.0	No	Ramp XSlope (%)	2.4
N/A	Flare Type LT	N/A	N/A	Flare Type RT	N/A
N/A	Flare Slope LT (%)	N/A	N/A	Flare Slope RT (%)	N/A
N/A	Flare Traversable LT?	N/A	N/A	Flare Traversable RT?	N/A
N/A	Landing Length (in)	N/A	N/A	DWS Provided?	N/A
N/A	Landing Width (in)	N/A	N/A	DWS Contrast?	N/A
N/A	Landing Slope (%)	N/A	N/A	DWS Length (in)	N/A
N/A	Landing X Slope (%)	N/A	N/A	DWS Full Width?	N/A
N/A	Landing Curb? (Y/N)	N/A	N/A	DWS Offset (in)	N/A
N/A	Shared Landing?	N/A			
N/A	Gutter Ponding?	N/A	N/A	Gutter Slope (%)	N/A
N/A	Gutter Lip Ht (in)	N/A	N/A	Gutter X Slope (%)	N/A
N/A	Painted X Walk1?	Yes	N/A	Painted X Walk2?	N/A
	X Walk 1 Direction	To NE		X Walk 2 Direction	N/A
N/A	X Walk 1 Width (in)	102.0	N/A	X Walk 2 Width (in)	N/A
	X Walk 1 Slope (%)	2.2		X Walk 2 Slope (%)	N/A
	X Walk 1 X Slope (%)	3.1		X Walk 2 X Slope (%)	N/A

N/A	Ramp inside XWalk1?	Yes	N/A	Ramp inside XWalk2?	N/A
	Road Slope (%)	N/A	N/A	Clear Space?	N/A
	Road X Slope (%)	N/A	N/A	Clear Space to XWalk (in)	N/A
N/A	Any Obstructions?	N/A	N/A	Storm Grate/Utility Hazard?	N/A
	Obstruction Type			Storm Grate/Utility Type	
		N/A			N/A
			Yes	Surface Condition? (G/P)	Good

**Remove & Replace Entire Ramp.**

**R304.2.2, R304.5.3**

Total Cost: \$ 1850.00
