# Access Compliance Report

## Public Rights-of-Way

### (Curb Ramps)

Intersection ID: 9231	Main Street: THE_PLAZA	Cross Street: PLOTT_RD	Location: SW
ADA ID: 6C540C37A75E	Ramp Type: Perp	Initial Pass/Fail: Fail	Overall Compliance: No
		Severity Score: 10

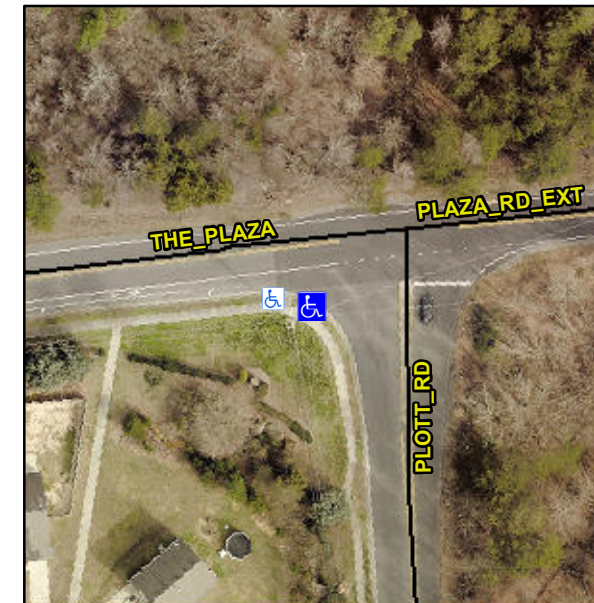
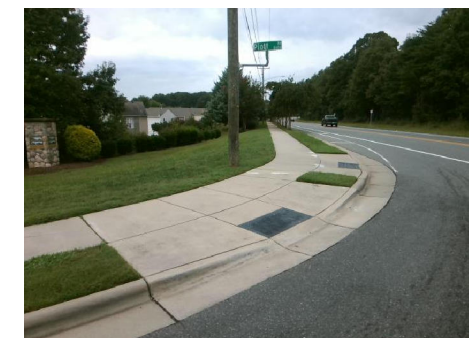
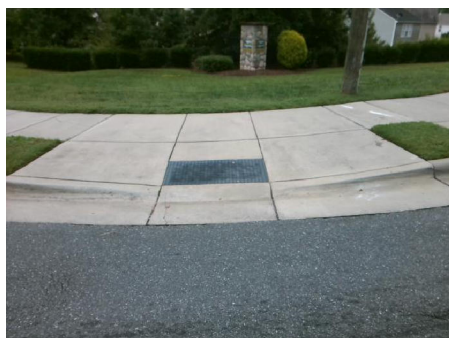
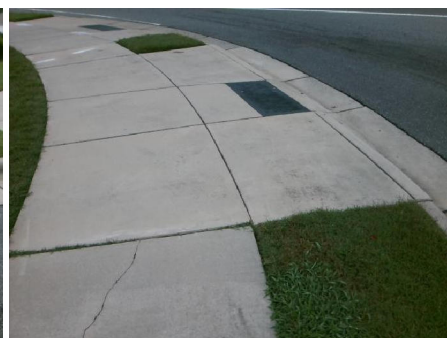
**Not Found, R304.5.1, R304.5.3**

Compliance	Description	Data	Compliance	Description	Data
N/A	Ramp Length (in)	50.0	Yes	Ramp Slope (%)	6.8
No	Ramp Width (in)	47.0	No	Ramp XSlope (%)	4.0
N/A	Flare Type LT	N/A	N/A	Flare Type RT	N/A
N/A	Flare Slope LT (%)	N/A	N/A	Flare Slope RT (%)	N/A
N/A	Flare Traversable LT?	N/A	N/A	Flare Traversable RT?	N/A
N/A	Landing Length (in)	N/A	N/A	DWS Provided?	N/A
N/A	Landing Width (in)	N/A	N/A	DWS Contrast?	N/A
N/A	Landing Slope (%)	N/A	N/A	DWS Length (in)	N/A
N/A	Landing X Slope (%)	N/A	N/A	DWS Full Width?	N/A
N/A	Landing Curb? (Y/N)	N/A	N/A	DWS Offset (in)	N/A
N/A	Shared Landing?	N/A			
N/A	Gutter Ponding?	N/A	N/A	Gutter Slope (%)	N/A
N/A	Gutter Lip Ht (in)	N/A	N/A	Gutter X Slope (%)	N/A
N/A	Painted X Walk1?	No	N/A	Painted X Walk2?	N/A
	X Walk 1 Direction	To E		X Walk 2 Direction	N/A
N/A	X Walk 1 Width (in)	N/A	N/A	X Walk 2 Width (in)	N/A
	X Walk 1 Slope (%)	4.5		X Walk 2 Slope (%)	N/A
	X Walk 1 X Slope (%)	3.8		X Walk 2 X Slope (%)	N/A

N/A	Ramp inside XWalk1?	N/A	N/A	Ramp inside XWalk2?	N/A
	Road Slope (%)	3.8	N/A	Clear Space?	N/A
	Road X Slope (%)	4.5	N/A	Clear Space to XWalk (in)	N/A
N/A	Any Obstructions?	N/A	N/A	Storm Grate/Utility Hazard?	N/A
	Obstruction Type			Storm Grate/Utility Type	
		N/A			N/A
			Yes	Surface Condition? (G/P)	Good

**Remove & Replace Entire Ramp.**

Total Cost: \$ 1850.00
