# Access Compliance Report

## Public Rights-of-Way

### (Curb Ramps)

| Intersection ID: 30073 | Main Street: SUNSET_RD | Cross Street: SUNSET_VILLAGE_DR | Location: NE |

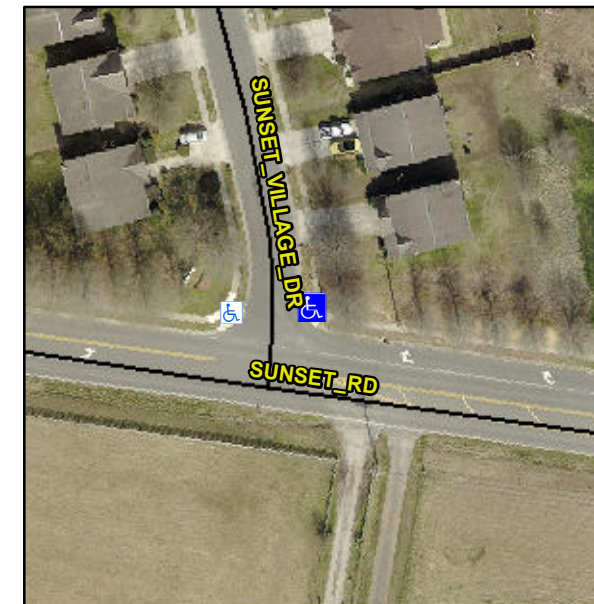
| ADA ID: 6C556FD32757 | Ramp Type: Perp | Initial Pass/Fail: Fail | Overall Compliance: No |

**Not Found, R304.5.1, R304.5.3**

| Compliance | Description | Data | Compliance | Description | Data |
|---|---|---|---|---|---|
| N/A | Ramp Length (in) | 44.5 | Yes | Ramp Slope (%) | 5.3 |
| No | Ramp Width (in) | 39.0 | No | Ramp XSlope (%) | 2.7 |

**Remove & Replace Entire Ramp.**

Total Cost: \$ 1850.00
