# Access Compliance Report

## Public Rights-of-Way

### (Curb Ramps)

Intersection ID: N/A	Main Street: UNIVERSITY_CITY_BV	Cross Street: N/A	Location: SE
ADA ID: 6C5912D2379D	Ramp Type: Perp	Initial Pass/Fail: Fail	Overall Compliance: No
Codes/Mitigation Info/Possible Solution		Field Measurements/Component Compliance

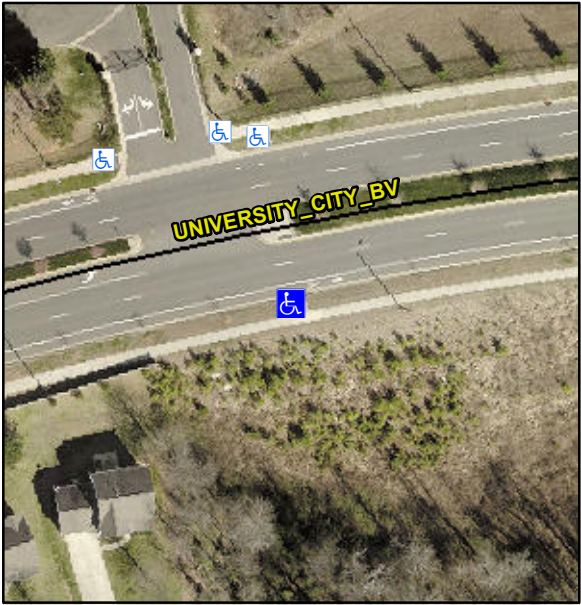
Possible Solutions:	Compliance	Description	Data	Compliance	Description	Data
	Remove & Replace Entire Ramp.	N/A	Ramp Length (in)	96.5	No	Ramp Slope (%)	10.1
		Yes	Ramp Width (in)	69.0	Yes	Ramp XSlope (%)	3.0
		N/A	Flare Type LT	N/A	N/A	Flare Type RT	N/A
		N/A	Flare Slope LT (%)	N/A	N/A	Flare Slope RT (%)	N/A
		N/A	Flare Traversable LT?	N/A	N/A	Flare Traversable RT?	N/A
		N/A	Landing Length (in)	N/A	N/A	DWS Provided?	N/A
		N/A	Landing Width (in)	N/A	N/A	DWS Contrast?	N/A
		N/A	Landing Slope (%)	N/A	N/A	DWS Length (in)	N/A
		N/A	Landing X Slope (%)	N/A	N/A	DWS Full Width?	N/A
		N/A	Landing Curb? (Y/N)	N/A	N/A	DWS Offset (in)	N/A
		N/A	Shared Landing?	N/A			
		N/A	Gutter Ponding?	N/A	N/A	Gutter Slope (%)	N/A
		N/A	Gutter Lip Ht (in)	N/A	N/A	Gutter X Slope (%)	N/A
		N/A	Painted X Walk1?	No	N/A	Painted X Walk2?	N/A
			X Walk 1 Direction	To N		X Walk 2 Direction	N/A
		N/A	X Walk 1 Width (in)	N/A	N/A	X Walk 2 Width (in)	N/A

X Walk 1 Slope (%)	1.0		X Walk 2 Slope (%)	N/A
			X Walk 1 X Slope (%)	3.8		X Walk 2 X Slope (%)	N/A
		N/A	Ramp inside XWalk1?	N/A	N/A	Ramp inside XWalk2?	N/A
<p>Surveyor Notes:</p> <p>N/A</p> <p>PROW/ADA:</p> <p>Not Found, R304.2.2</p>			Road Slope (%)	N/A	N/A	Clear Space?	N/A
			Road X Slope (%)	N/A	N/A	Clear Space to XWalk (in)	N/A
		N/A	Any Obstructions?	N/A	N/A	Storm Grate/Utility Hazard?	N/A
			Obstruction Type			Storm Grate/Utility Type	
				N/A			N/A
Total Cost:		\$	1850.00		Yes	Surface Condition? (G/P)	Good
