Access Compliance Report

Public Rights-of-Way

(Curb Ramps)

Intersection ID: 2766	Main Street: CARDINAL_POINT_RD	Cross Street: JADE_TREE_LN	Location: W
ADA ID: 6C60D9AA3A6F	Ramp Type: BlendTrans2	Initial Pass/Fail: Fail	Overall Compliance: No
		Severity Score: 1.25

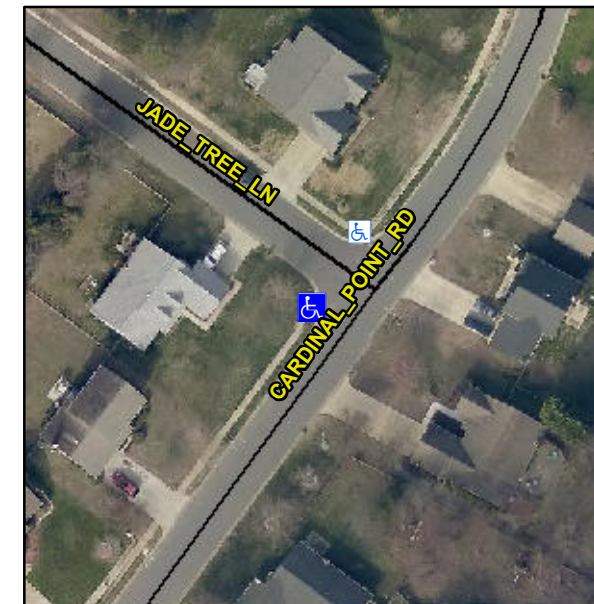
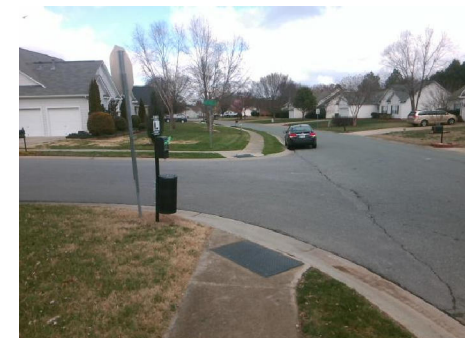
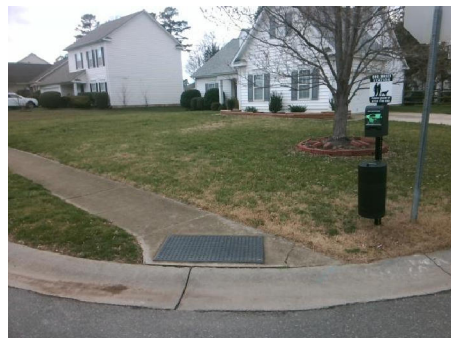
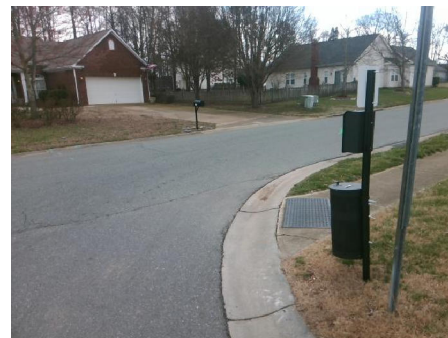
Not Found, R304.5.3

Compliance	Description	Data	Compliance	Description	Data
N/A	Ramp Length (in)	36.0	Yes	BlendTrans Slope (%)	3.5
Yes	Ramp Width (in)	48.0	No	BlendTrans XSlope (%)	2.1
N/A	Flare Type LT	N/A	N/A	Flare Type RT	N/A
N/A	Flare Slope LT (%)	N/A	N/A	Flare Slope RT (%)	N/A
N/A	Flare Traversable LT?	N/A	N/A	Flare Traversable RT?	N/A
N/A	Landing Length (in)	N/A	N/A	DWS Provided?	N/A
N/A	Landing Width (in)	N/A	N/A	DWS Contrast?	N/A
N/A	Landing Slope (%)	N/A	N/A	DWS Length (in)	N/A
N/A	Landing X Slope (%)	N/A	N/A	DWS Full Width?	N/A
N/A	Landing Curb? (Y/N)	N/A	N/A	DWS Offset (in)	N/A
N/A	Shared Landing?	N/A			
N/A	Gutter Ponding?	N/A	N/A	Gutter Slope (%)	N/A
N/A	Gutter Lip Ht (in)	N/A	N/A	Gutter X Slope (%)	N/A
N/A	Painted X Walk1?	No	N/A	Painted X Walk2?	N/A
	X Walk 1 Direction	To NE		X Walk 2 Direction	N/A
	X Walk 1 Width (in)	N/A		X Walk 2 Width (in)	N/A
	X Walk 1 Slope (%)	0.2		X Walk 2 Slope (%)	N/A
	X Walk 1 X Slope (%)	1.3		X Walk 2 X Slope (%)	N/A

N/A	Ramp inside XWalk1?	N/A	N/A	Ramp inside XWalk2?	N/A
	Road Slope (%)	1.3		Clear Space?	N/A
	Road X Slope (%)	0.2	N/A	Clear Space to XWalk (in)	N/A
N/A	Any Obstructions?	N/A	N/A	Storm Grate/Utility Hazard?	N/A
	Obstruction Type			Storm Grate/Utility Type	
		N/A			N/A
			Yes	Surface Condition? (G/P)	Good
			No	Curb Slope (%)	28.8

Remove & Replace Curb Ramp With Two New Directional Ramps or Equivalent.
