Access Compliance Report Public Rights-of-Way (Curb Ramps)

Intersection ID: 8421Main Street: OLD_CONCORD_RDCross Street: MCDANIEL_LNLocation: NWADA ID: 6C639E81676ARamp Type: PerpDiagInitial Pass/Fail: PassOverall Compliance: NoSeverity Score: 37.5

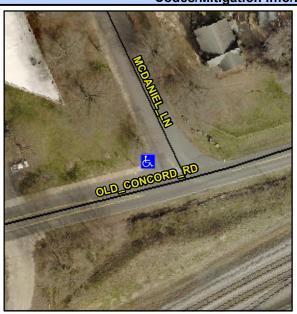
Compliance Description Data Compliance Description Data Yes Ramp Slope (%) N/A Ramp Length (in) 58.0 6.8 48.0 Yes Ramp XSlope (%) Yes Ramp Width (in) 8.0 N/A Flare Type LT Sloped N/A Flare Type RT N/A N/A 10.9 Yes Flare Slope RT (%) Flare Slope LT (%) 8.9 N/A Flare Traversable LT? Yes N/A Flare Traversable RT? Yes No N/A No DWS Provided? Landing Length (in) No No Landing Width (in) N/A N/A **DWS Contrast?** No N/A N/A No Landing Slope (%) DWS Length (in) N/A No Landing X Slope (%) N/A N/A DWS Full Width? No N/A Landing Curb? (Y/N) No N/A DWS Offset (in) N/A N/A Shared Landing? No Gutter Ponding? No Yes Gutter Slope (%) Yes 1.3 No Gutter Lip Ht (in) 1.0 Yes Gutter X Slope (%) 1.4 N/A Painted X Walk1? No N/A Painted X Walk2? No X Walk 1 Direction To S X Walk 2 Direction To E N/A N/A X Walk 1 Width (in) X Walk 2 Width (in) N/A X Walk 1 Slope (%) 0.6 X Walk 2 Slope (%) 2.0 X Walk 1 X Slope (%) 1.6 X Walk 2 X Slope (%) 1.4 N/A N/A N/A Ramp inside XWalk2? N/A Ramp inside XWalk1? Road Slope (%) 2.1 N/A Clear Space? Yes N/A Road X Slope (%) 1.6 Clear Space to XWalk (in) N/A No Yes Any Obstructions? Yes Storm Grate/Utility Hazard? No **Obstruction Type** Storm Grate/Utility Type N/A N/A

Remove & Replace Curb Ramp With Two New Directional Ramps or Equivalent.
