# Access Compliance Report

## Public Rights-of-Way

| Intersection ID: 53927 | Main Street: PRESTON_KNOLL_LN | Cross Street: BRITTONDALE_LN | Location: SW |
| ADA ID: 6C66106DF811 | Ramp Type: PerpDiag | Initial Pass/Fail: Fail | Overall Compliance: No |

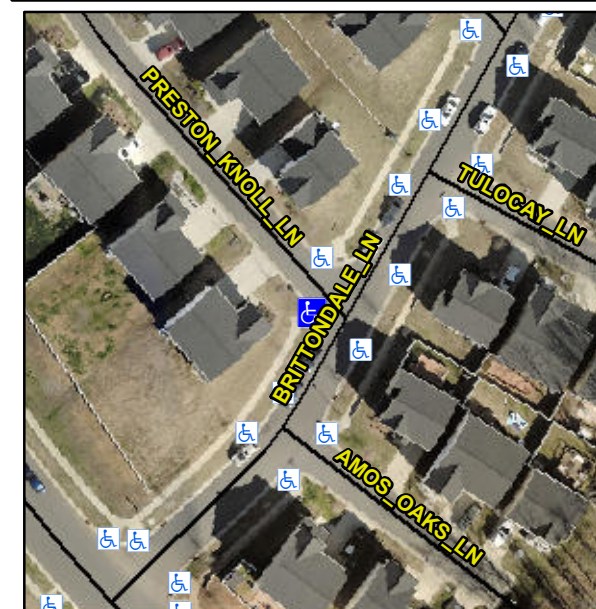
| Severity Score: 22.5 | | | |

**R304.5.1, R304.2.2, R304.5.3**

| Compliance | Description | Data | Compliance | Description | Data |
|---|---|---|---|---|---|
| N/A | Ramp Length (in) | 94.0 | No | Ramp Slope (%) | 9.1 |
| No | Ramp Width (in) | 44.0 | No | Ramp XSlope (%) | 2.2 |

**Remove & Replace Curb Ramp With Two New Directional Ramps or Equivalent.**

Total Cost: \$ 3200.00

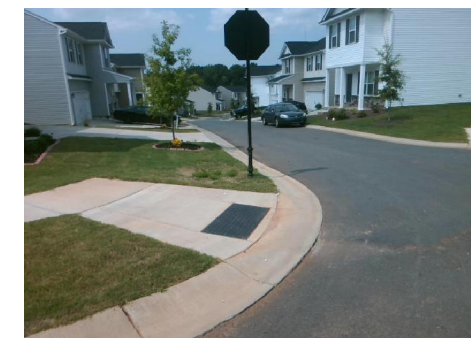
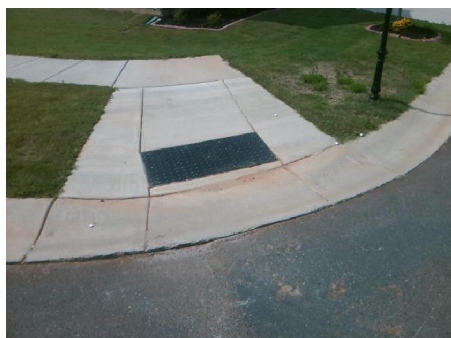
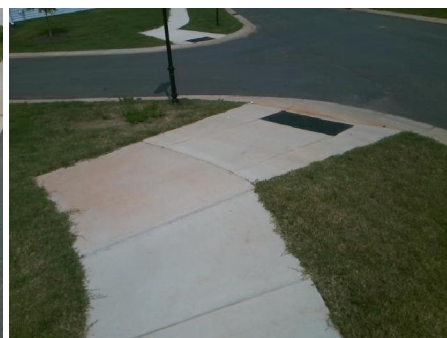
Street 1 Name **BRITTONDALE LN**  
 Stop Condition-Street 2 **None**  
 Street 2 Name **PRESTON KNOLL LN**  
 Stop Condition-Street 1 **StopSign**
