Access Compliance Report Public Rights-of-Way (Curb Ramps)

Intersection ID: 11731 Main Street: E_W_T_HARRIS_BV Cross Street: GROVE_PARK_BV Location: E

ADA ID: 6C6CF30C6219 Ramp Type: PerpDiag Initial Pass/Fail: Fail Overall Compliance: No Severity Score: 13.75

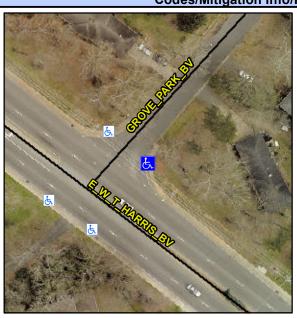
Not Found, R304.2.2, R304.5.3

Field Measure	ements/C	<u>ompo</u>	nent Compliar	nce	
Compliance Description		Data	Compliance Description		Data	
N/A	Ramp Length (in)	61.0	No	Ramp Slope (%)	9.7
Yes	Ramp Width (in)	48.0	No	Ramp XSlope (9	%)	3.2
N/A	Flare Type LT	N/A	N/A	Flare Type RT		N/A
N/A	Flare Slope LT (%)	N/A	N/A	Flare Slope RT	(%)	N/A
N/A	Flare Traversable LT?	N/A	N/A	Flare Traversab	le RT?	N/A
N/A	Landing Length (in)	N/A	N/A	DWS Provided?)	N/A
N/A	Landing Width (in)	N/A	N/A	DWS Contrast?		N/A
N/A	Landing Slope (%)	N/A	N/A	DWS Length (in)	N/A
N/A	Landing X Slope (%)	N/A	N/A	DWS Full Width	?	N/A
N/A	Landing Curb? (Y/N)	N/A	N/A	DWS Offset (in)		N/A
N/A	Shared Landing?	N/A				
N/A	Gutter Ponding?	N/A	N/A	Gutter Slope (%)	N/A
N/A	Gutter Lip Ht (in)	N/A	N/A	Gutter X Slope	(%)	N/A
N/A	Painted X Walk1?	No	N/A	Painted X Walk	2?	No
	X Walk 1 Direction	To NW		X Walk 2 Directi	ion	To SW
N/A	X Walk 1 Width (in)	N/A	N/A	X Walk 2 Width	(in)	N/A

X Walk 1 Slope (%)	0.4		X Walk 2 Slope	(%)	2.7
	X Walk 1 X Slope (%)	4.0		X Walk 2 X Slop	oe (%)	0.3
N/A	Ramp inside XWalk1?	N/A	N/A	Ramp inside XV	Valk2?	N/A
	Road Slope (%)	2.8	N/A	Clear Space?		N/A
	Road X Slope (%)	0.7	N/A	Clear Space to	XWalk (in)	N/A
N/A	Any Obstructions?	N/A	N/A	Storm Grate/Uti	lity Hazard?	N/A
	Obstruction Type		l	Storm Grate/Uti	lity Type	
		N/A				N/A

Remove & Replace Curb Ramp With Two New Directional Ramps or Equivalent.
