Access Compliance Report

Public Rights-of-Way

(Curb Ramps)

Intersection ID: 21831	Main Street: ENGLAND_ST	Cross Street: WINDSOR_OAK_CT	Location: SW
ADA ID: 6C771A3F72F0	Ramp Type: PerpDiag	Initial Pass/Fail: Fail	Overall Compliance: No
Severity Score: 13.75			
Codes/Mitigation Info/Possible Solution		Field Measurements/Component Compliance

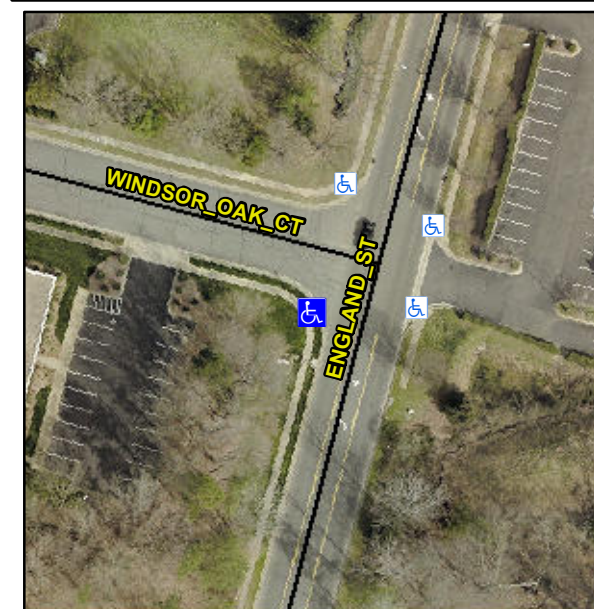
Not Found, R304.2.2, R304.5.3

Compliance	Description	Data	Compliance	Description	Data
N/A	Ramp Length (in)	93.0	No	Ramp Slope (%)	8.7
Yes	Ramp Width (in)	48.0	No	Ramp XSlope (%)	4.1
N/A	Flare Type LT	N/A	N/A	Flare Type RT	N/A
N/A	Flare Slope LT (%)	N/A	N/A	Flare Slope RT (%)	N/A
N/A	Flare Traversable LT?	N/A	N/A	Flare Traversable RT?	N/A
N/A	Landing Length (in)	N/A	N/A	DWS Provided?	N/A
N/A	Landing Width (in)	N/A	N/A	DWS Contrast?	N/A
N/A	Landing Slope (%)	N/A	N/A	DWS Length (in)	N/A
N/A	Landing X Slope (%)	N/A	N/A	DWS Full Width?	N/A
N/A	Landing Curb? (Y/N)	N/A	N/A	DWS Offset (in)	N/A
N/A	Shared Landing?	N/A			
N/A	Gutter Ponding?	N/A	N/A	Gutter Slope (%)	N/A
N/A	Gutter Lip Ht (in)	N/A	N/A	Gutter X Slope (%)	N/A
N/A	Painted X Walk1?	No	N/A	Painted X Walk2?	No
	X Walk 1 Direction	To SE		X Walk 2 Direction	To NE
N/A	X Walk 1 Width (in)	N/A	N/A	X Walk 2 Width (in)	N/A
	X Walk 1 Slope (%)	2.1		X Walk 2 Slope (%)	3.4
	X Walk 1 X Slope (%)	4.3		X Walk 2 X Slope (%)	1.2

N/A	Ramp inside XWalk1?	N/A	N/A	Ramp inside XWalk2?	N/A
	Road Slope (%)	4.3	N/A	Clear Space?	N/A
	Road X Slope (%)	3.1	N/A	Clear Space to XWalk (in)	N/A
N/A	Any Obstructions?	N/A	N/A	Storm Grate/Utility Hazard?	N/A
	Obstruction Type			Storm Grate/Utility Type	
		N/A			N/A
		Yes		Surface Condition? (G/P)	Good

Possible Solutions:

Remove & Replace Curb Ramp With Two New Directional Ramps or Equivalent.
