Access Compliance Report

Public Rights-of-Way

(Curb Ramps)

Intersection ID: 15246	Main Street: HEFLIN_ST	Cross Street: MCVAY_ST	Location: NW
ADA ID: 6C7750CFDF88	Ramp Type: Directional1	Initial Pass/Fail: Fail	Overall Compliance: No
Codes/Mitigation Info/Possible Solution		Severity Score: 12.5	
		Field Measurements/Component Compliance

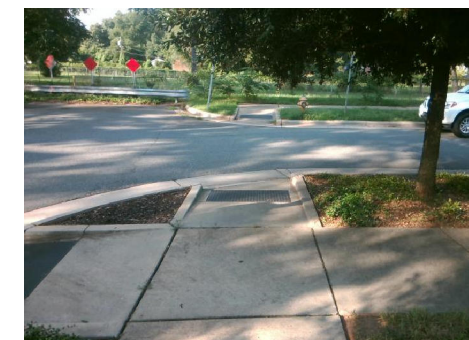
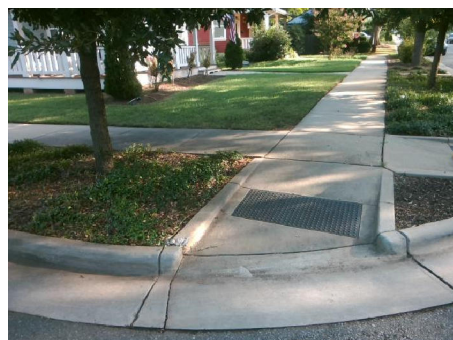
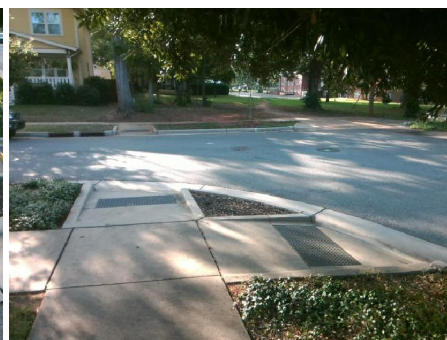
Compliance	Description	Data	Compliance	Description	Data
N/A	Ramp Length (in)	64.0	N/A	Grade Break?	N/A
Yes	Ramp Width (in)	60.0	N/A	Grade Break Slope (%)	0.0
No	Ramp Slope (%)	10.6	N/A	Grade Break XSlope (%)	0.0
Yes	Ramp XSlope (%)	0.7			
N/A	Flare Type LT	N/A	N/A	Flare Type RT	N/A
N/A	Flare Slope LT (%)	N/A	N/A	Flare Slope RT (%)	0.0
N/A	Flare Traversable LT?	N/A	N/A	Flare Traversable RT?	N/A
N/A	Landing Length (in)	0.0	N/A	DWS Provided?	N/A
N/A	Landing Width (in)	0.0	N/A	DWS Contrast?	N/A
N/A	Landing Slope (%)	0.0	N/A	DWS Length (in)	N/A
N/A	Landing X Slope (%)	0.0	N/A	DWS Full Width?	N/A
N/A	Landing Curb? (Y/N)	N/A	N/A	DWS Offset LT (in)	N/A
N/A	Shared Landing?	N/A	N/A	DWS Offset RT (in)	N/A
N/A	Gutter Ponding?	0.0	N/A	Gutter Slope (%)	N/A
N/A	Gutter Lip Ht (in)	0.0	N/A	Gutter X Slope (%)	N/A
N/A	Painted X Walk1?	No		Road Slope (%)	1.4
	X Walk 1 Direction	To S		Road X Slope (%)	1.8
	X Walk 1 Width (in)	N/A		Clear Space?	N/A

X Walk 1 Slope (%)	1.4	N/A	Clear Space to XWalk (in)	N/A
	X Walk 1 X Slope (%)	1.8	N/A	Storm Grate/Utility Hazard?	N/A
N/A	Ramp inside XWalk1?	N/A		Storm Grate/Utility Type	
N/A	Any Obstructions?	N/A			
	Obstruction Type		Yes	Surface Condition? (G/P)	Good
			N/A	Curb Slope (%)	21.7

Remove & Replace Entire Ramp.
