Access Compliance Report

Public Rights-of-Way

(Curb Ramps)

Intersection ID: 10390	Main Street: ENDERLY_RD	Cross Street: TUCKASEEGEE_RD	Location: SE
ADA ID: 6C817B11FFA1	Ramp Type: Perp	Initial Pass/Fail: Fail	Overall Compliance: No
		Severity Score: 10

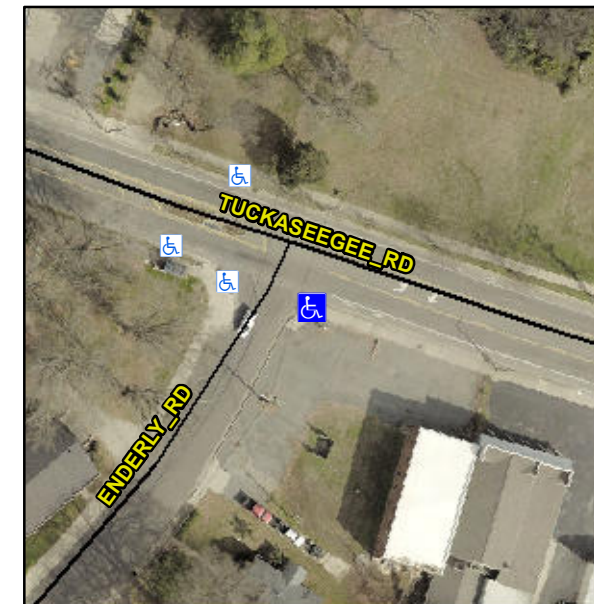
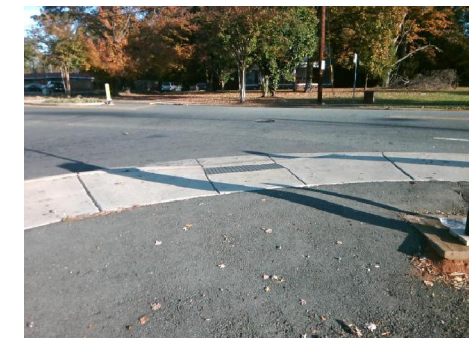
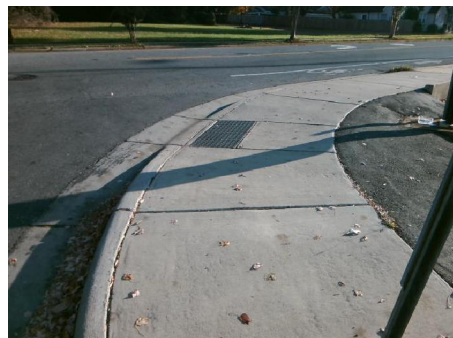
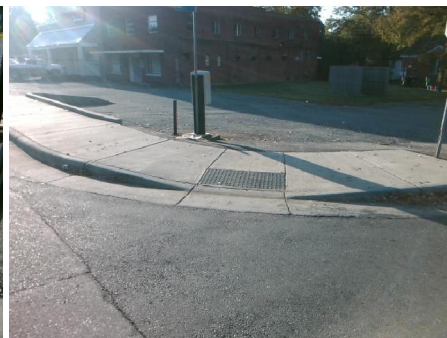
Compliance	Description	Data	Compliance	Description	Data
N/A	Ramp Length (in)	72.0	Yes	Ramp Slope (%)	6.2
No	Ramp Width (in)	42.0	No	Ramp XSlope (%)	2.9
N/A	Flare Type LT	N/A	N/A	Flare Type RT	N/A
N/A	Flare Slope LT (%)	N/A	N/A	Flare Slope RT (%)	N/A
N/A	Flare Traversable LT?	N/A	N/A	Flare Traversable RT?	N/A
N/A	Landing Length (in)	N/A	N/A	DWS Provided?	N/A
N/A	Landing Width (in)	N/A	N/A	DWS Contrast?	N/A
N/A	Landing Slope (%)	N/A	N/A	DWS Length (in)	N/A
N/A	Landing X Slope (%)	N/A	N/A	DWS Full Width?	N/A
N/A	Landing Curb? (Y/N)	N/A	N/A	DWS Offset (in)	N/A
N/A	Shared Landing?	N/A			
N/A	Gutter Ponding?	N/A	N/A	Gutter Slope (%)	N/A
N/A	Gutter Lip Ht (in)	N/A	N/A	Gutter X Slope (%)	N/A
N/A	Painted X Walk1?	No	N/A	Painted X Walk2?	N/A
	X Walk 1 Direction	To NW		X Walk 2 Direction	N/A
N/A	X Walk 1 Width (in)	N/A	N/A	X Walk 2 Width (in)	N/A
	X Walk 1 Slope (%)	1.0		X Walk 2 Slope (%)	N/A
	X Walk 1 X Slope (%)	6.2		X Walk 2 X Slope (%)	N/A

N/A	Ramp inside XWalk1?	N/A	N/A	Ramp inside XWalk2?	N/A
	Road Slope (%)	N/A	N/A	Clear Space?	N/A
	Road X Slope (%)	N/A	N/A	Clear Space to XWalk (in)	N/A
N/A	Any Obstructions?	N/A	N/A	Storm Grate/Utility Hazard?	N/A
	Obstruction Type			Storm Grate/Utility Type	
		N/A			N/A
			Yes	Surface Condition? (G/P)	Good

Remove & Replace Entire Ramp.

R304.5.1, R304.5.3
