# Access Compliance Report

## Public Rights-of-Way

### (Curb Ramps)

Intersection ID: 10450	Main Street: ROZZELLES_FERRY_RD	Cross Street: WALFORD_DR	Location:	N
ADA ID: 6C885B9E6E15	Ramp Type: Perp	Initial Pass/Fail: Fail	Overall Compliance: No	Severity Score: 47.5
Codes/Mitigation Info/Possible Solution		Field Measurements/Component Compliance

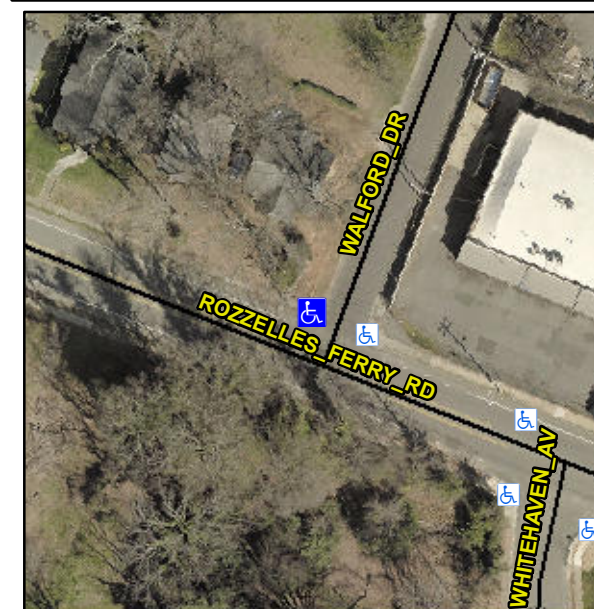
**Not Found, R304.5.1, R304.5.3**

Compliance	Description	Data	Compliance	Description	Data
N/A	Ramp Length (in)	56.5	Yes	Ramp Slope (%)	8.0
No	Ramp Width (in)	30.5	No	Ramp XSlope (%)	6.7
N/A	Flare Type LT	N/A	N/A	Flare Type RT	N/A
N/A	Flare Slope LT (%)	N/A	N/A	Flare Slope RT (%)	N/A
N/A	Flare Traversable LT?	N/A	N/A	Flare Traversable RT?	N/A
N/A	Landing Length (in)	N/A	N/A	DWS Provided?	N/A
N/A	Landing Width (in)	N/A	N/A	DWS Contrast?	N/A
N/A	Landing Slope (%)	N/A	N/A	DWS Length (in)	N/A
N/A	Landing X Slope (%)	N/A	N/A	DWS Full Width?	N/A
N/A	Landing Curb? (Y/N)	N/A	N/A	DWS Offset (in)	N/A
N/A	Shared Landing?	N/A			
N/A	Gutter Ponding?	N/A	N/A	Gutter Slope (%)	N/A
N/A	Gutter Lip Ht (in)	N/A	N/A	Gutter X Slope (%)	N/A
N/A	Painted X Walk1?	No	N/A	Painted X Walk2?	N/A
	X Walk 1 Direction	To SE		X Walk 2 Direction	N/A
N/A	X Walk 1 Width (in)	N/A	N/A	X Walk 2 Width (in)	N/A
	X Walk 1 Slope (%)	4.6		X Walk 2 Slope (%)	N/A
	X Walk 1 X Slope (%)	2.1		X Walk 2 X Slope (%)	N/A

N/A	Ramp inside XWalk1?	N/A	N/A	Ramp inside XWalk2?	N/A
	Road Slope (%)	N/A	N/A	Clear Space?	N/A
	Road X Slope (%)	N/A	N/A	Clear Space to XWalk (in)	N/A
N/A	Any Obstructions?	N/A	N/A	Storm Grate/Utility Hazard?	N/A
	Obstruction Type			Storm Grate/Utility Type	
		N/A			N/A
			Yes	Surface Condition? (G/P)	Good

**Remove & Replace Entire Ramp.**

Total Cost: \$ 1850.00
