## Access Compliance Report Public Rights-of-Way (Curb Ramps)

Intersection ID: 31201 Main Street: WRAYHILL\_DR Cross Street: OLDCORN\_LN Location: SW

ADA ID: 6C910264F3E3 Ramp Type: Perp Initial Pass/Fail: Fail Overall Compliance: No Severity Score: 8.75

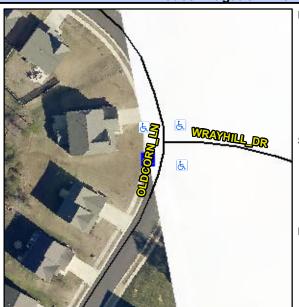
Field Measurements/Component Compliance								
Compl	iance Description	Data	Comp	liance Description	Data			
N/A	Ramp Length (in)	48.0	Yes	Ramp Slope (%)	7.9			
No	Ramp Width (in)	47.0	Yes Ramp XSlope (%)		1.5			
N/A	Flare Type LT	N/A	N/A Flare Type RT		N/A			
N/A	Flare Slope LT (%)	N/A	N/A	Flare Slope RT (%)	N/A			
N/A	Flare Traversable LT?	N/A	N/A	Flare Traversable RT?	N/A			
N/A	Landing Length (in)	N/A	N/A	DWS Provided?	N/A			
N/A	Landing Width (in)	N/A	N/A	DWS Contrast?	N/A			
N/A	Landing Slope (%)	N/A	N/A	DWS Length (in)	N/A			
N/A	Landing X Slope (%)	N/A	N/A	DWS Full Width?	N/A			
N/A	Landing Curb? (Y/N)	N/A	N/A	DWS Offset (in)	N/A			
N/A	Shared Landing?	N/A						
N/A	Gutter Ponding?	N/A	N/A	Gutter Slope (%)	N/A			
N/A	Gutter Lip Ht (in)	N/A	N/A	Gutter X Slope (%)	N/A			
N/A	Painted X Walk1?	No	N/A	Painted X Walk2?	N/A			
	X Walk 1 Direction	То Е		X Walk 2 Direction	N/A			
N/A	X Walk 1 Width (in)	N/A	N/A	X Walk 2 Width (in)	N/A

Possible Solutions:						
Remove & Replace Entire Ramp.						
Surveyor Notes:						
N/A						
N/A						
PROW/ADA:						
Not Found, R304.5.1
