Access Compliance Report

Public Rights-of-Way

(Curb Ramps)

Intersection ID: 11450	Main Street: GRANDIN_RD	Cross Street: W MARTIN LUTHER KING JR BV	Location: W
ADA ID: 6C9751BEC6D4	Ramp Type: BlendTrans1	Initial Pass/Fail: Fail	Overall Compliance: No
		Severity Score: 10

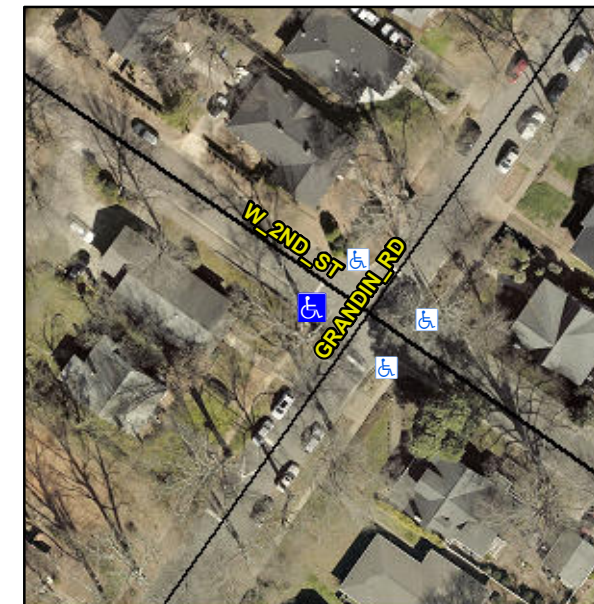
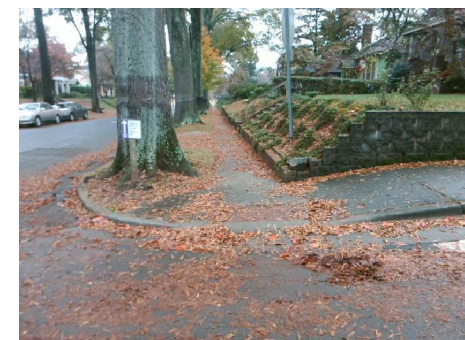
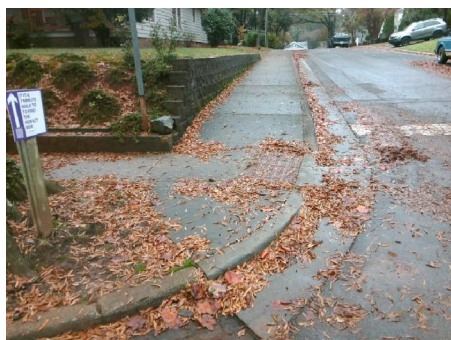
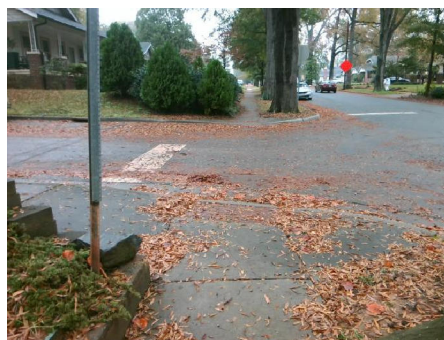
RAMP LIP 0.5

Not Found, R304.5.1, R304.5.3

Compliance	Description	Data	Compliance	Description	Data
N/A	Ramp Length (in)	66.0	Yes	BlendTrans Slope (%)	1.8
No	Ramp Width (in)	47.0	No	BlendTrans XSlope (%)	4.9
N/A	Flare Type LT	N/A	N/A	Flare Type RT	N/A
N/A	Flare Slope LT (%)	N/A	N/A	Flare Slope RT (%)	N/A
N/A	Flare Traversable LT?	N/A	N/A	Flare Traversable RT?	N/A
N/A	Landing Length (in)	N/A	N/A	DWS Provided?	N/A
N/A	Landing Width (in)	N/A	N/A	DWS Contrast?	N/A
N/A	Landing Slope (%)	N/A	N/A	DWS Length (in)	N/A
N/A	Landing X Slope (%)	N/A	N/A	DWS Full Width?	N/A
N/A	Landing Curb? (Y/N)	N/A	N/A	DWS Offset (in)	N/A
N/A	Shared Landing?	N/A			
N/A	Gutter Ponding?	N/A	N/A	Gutter Slope (%)	N/A
N/A	Gutter Lip Ht (in)	N/A	N/A	Gutter X Slope (%)	N/A
N/A	Painted X Walk1?	No	N/A	Painted X Walk2?	N/A
	X Walk 1 Direction	To NE		X Walk 2 Direction	N/A
	X Walk 1 Width (in)	N/A		X Walk 2 Width (in)	N/A
	X Walk 1 Slope (%)	2.5		X Walk 2 Slope (%)	N/A
	X Walk 1 X Slope (%)	3.5		X Walk 2 X Slope (%)	N/A

N/A	Ramp inside XWalk1?	N/A	N/A	Ramp inside XWalk2?	N/A
	Road Slope (%)	3.5		Clear Space?	N/A
	Road X Slope (%)	2.5	N/A	Clear Space to XWalk (in)	N/A
N/A	Any Obstructions?	N/A	N/A	Storm Grate/Utility Hazard?	N/A
	Obstruction Type			Storm Grate/Utility Type	
		N/A			N/A
			Yes	Surface Condition? (G/P)	Good
			No	Curb Slope (%)	19.5

Remove & Replace Curb Ramp With Two New Directional Ramps or Equivalent.
